EVOLUTION OF THE LOWER MSZANKA CHANNEL SECTION AFTER TRAINING USING STAGE CORRECTION METHOD

Joanna Korpak

Cracow University of Technology

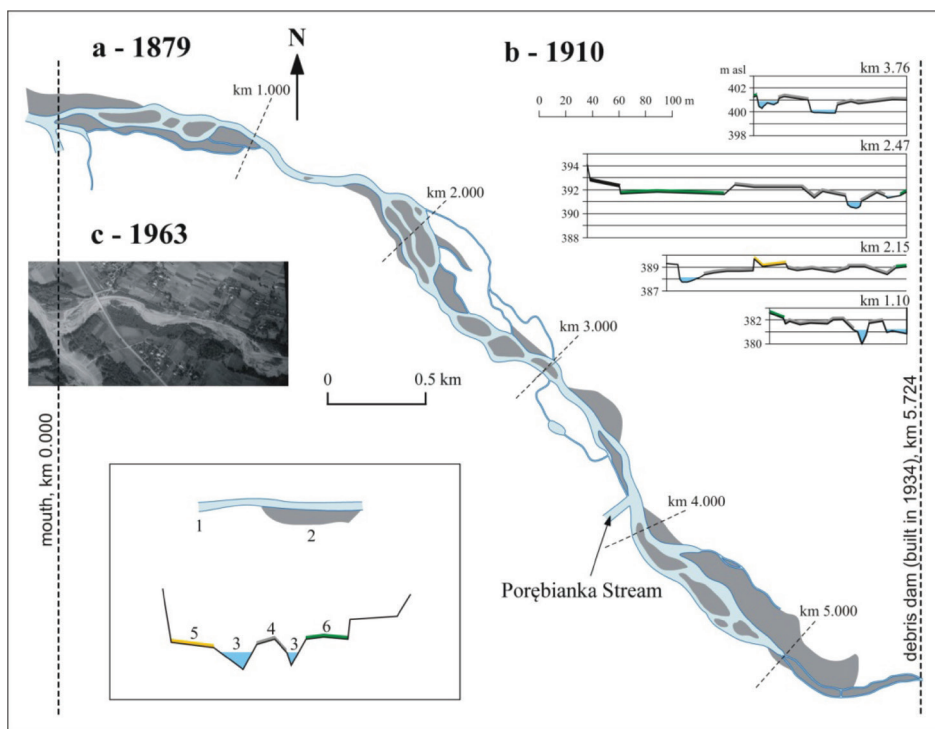
By the end of the 19th and at the beginning of the 20th century the channel in the lower Mszanka course was braided, alluvial with large central and lateral bars, some of which were utilised as pastures or arable lands (project no 11/90/8, 1910). The channel width exceeded 100 m, in some places reaching even 300 m (Fig. 2a, b). The river loading at this section considerably exceeded its transport ability, as evidenced by the deposition of carried material. Uplifting channel bottom posed a flood hazard for the adjoining agricultural lands. To stave off this problem, a decision was made to construct a debris dam which would arrest the transported material. The project was a part of the plan of systematic channel consolidation along a 12.5 km long Mszanka River reach, developed by the Commission for River Training in Galicia at Imperial-Royal Governorship in Lvov in 1910 (project 11/90/8, 1910). The project was never completed. The dam was constructed in 1934 at 5.724 km of the river in the valley necking. The channel was 20 m wide. The dam, one of the oldest in the Podkarpacie region was a stone structure with a height of 3.3 m. The fishway was situated on the right bank of the river. The dam reservoir capacity was 78,000 m³. In the subsequent years the structure was destroyed several times (by floods in 1964, 1970 and 1997) and renovated (the last time in 1999, project no. 1750, 2000). The dam broke the continuity of the fluvial system and divided the channel into two sections, which from that time were developing differently. Deposition dominated above the dam, whereas erosion below. The erosion undoubtedly occurred along about several hundred metres long section, situated immediately below the structure. Such length of the erosive section was suggested by the research on other channels below dams with similar dimensions (Korpak 2007b, Korpak *et al.* 2008). Deposition of material prevailed below this reach, as evidenced by the aerial photograph of 1963 (Fig. 2c). In this place the channel still remained braided, of a smaller width than at the turn of the 19th and 20th century, but still very wide (up to 160 m). Values of the minimum annual water stages reveal alternativeness of brief aggradation and degradation episode causing that until 1964 the channel at this cross section revealed vertical stability (Fig. 3).

Figure 2. Development of the lower section of the Mszanka channel before regulation: a – in 1879 (on the basis of the Austrian topographic map), b – channel cross sections in 1910 (according to the project no. 11/90/8, 1910), c – in 1963. 1 – water, 2 – bar, 3 – channel with water, 4 – bar, 5 – pasture, 6 – shrubs

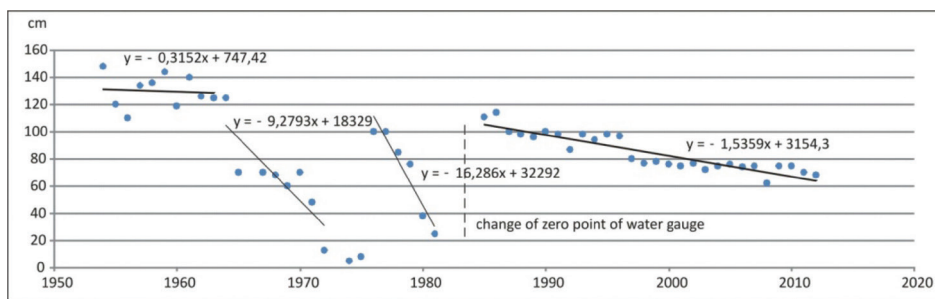
Figure 3. Lowering of the minimum annual water stages of the Mszanka River at the Mszana Dolna gauging station as an indicator of incision rates

reach below the debris dam. According to the minimum annual water stages at the Mszana Dolna gauging station, channel deepening at that time was very intensive. At various points of the longitudinal profile the bottom lowered by 1-3, usually by ca. 2 m (project 3337, 1977, Fig. 3). Information about the first period of stage correction realisation may be found in the aerial photograph of 1976 (Fig. 4a). It shows that the channel was levelled and its shape and bottom structure were destroyed. Subsequently, a new single-thread flow regulation route was constructed along the artificially delineated course line. Subsequent drop structures and steps were erected towards the river mouth. Width of the active channel decreased considerably.

Stage correction was developed in response to increased channel slope and its rapid deepening after construction of the debris dam at 5.724 km of the river. The strongest deepening occurred in the years: 1964-1972 and in 1976-1981 (Fig. 3). Training works were conducted between these periods, so the values of the minimum stages are incomparable. Each of the training stages comprised the channel narrowing, its straightening and cutting off lateral meanders, which considerably diminished the flow cross-section. The channel along river section trained with drop structures revealed a relative horizontal and vertical stability, whereas it was very unstable below. Problems appeared particularly during flood water flow. Flood water was flowing with a high velocity through the narrowed flow regulation route and strongly eroded the bottom and channel bank. Engineering structures were also damaged during floods. The training conducted to limit erosion did not eliminate the problem but moved it closer to the mouth. Therefore, sometime later a decision was made to train the next section. Finally the stage correction covered the whole length of the Mszanka lower course. However, the problem of erosion remained. The diagram of minimum water stages shows that the tendency for channel deepening lasts continuously in the channel, although the process is less intensive (Fig. 3). Strong erosion occurs in the Raba channel below its junction with the Mszanka. According to the course on minimal annual water stages over the last 100 years at water gauging station

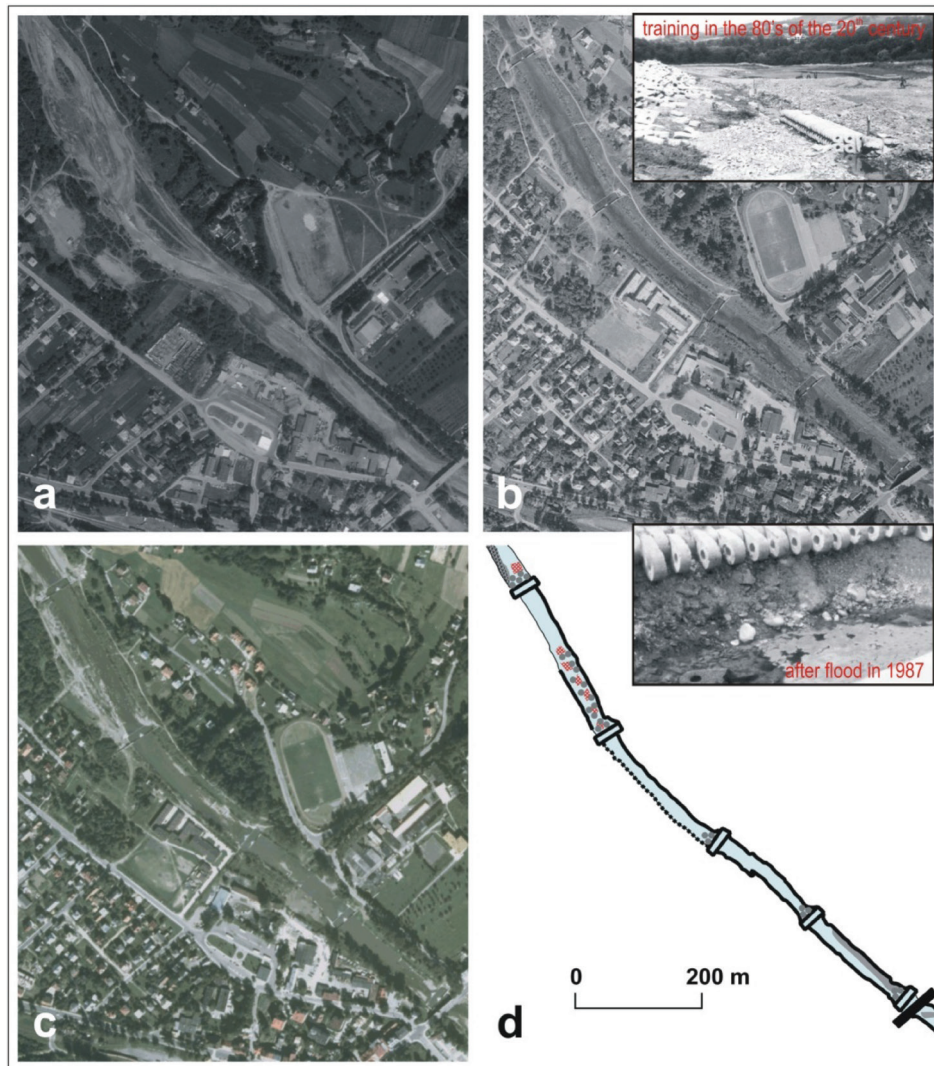
At that time the riverbed below the Porębianka River mouth was alluvial and locally divided into several arms, while its maximum width reached ca. 100 m (Fig. 5a, 6a). The river showed tendency for a lateral migration and going wild (Fig. 5a, 6a). Longitudinal training was conducted at several river sections to protect its banks against erosion (project no. 3337, 1977). The training is visible in aerial photographs (Fig. 6a).

gabion rock mattresses was damaged or totally destroyed and in these places 0.3-1.1m potholes formed. Concrete steps were scoured and 0.2-1.3 m deep potholes were forming below them. Some concrete steps and bank reinforcements were damaged or destroyed (Photo in Fig. 5b).

Figure 5. Change of the Mszanka channel morphology at the section regulated during the second period of training: a – 1976, b – 1993 (photographs of the as-built inventory of the flow regulation route acc. to project 4175), c – 1997, d – 2015 (based on terrain mapping). Legend as in Fig. 4.

Numerous bars, visible in the channel bed below the Porębianka mouth were mostly deposited during the flood (Fig. 5c). Many drop structures were partly or wholly covered by the bedload. Concave banks were undercut, which caused their local scouring and destruction of bank reinforcements. Renovation of the analysed channel section (3.928-2.140 km) was carried out in 1998 (acc. to Zestawienie... 2004). Both banks were armoured with concrete prefab bands and the channel was cleared by removing the accumulation forms. Subsequent renovation works were conducted after the flood in 2001.
