## **EVOLUTION OF THE LOWER MSZANKA CHANNEL SECTION AFTER TRAINING USING STAGE CORRECTION METHOD**

***Joanna Korpak***

*Cracow University of Technology*

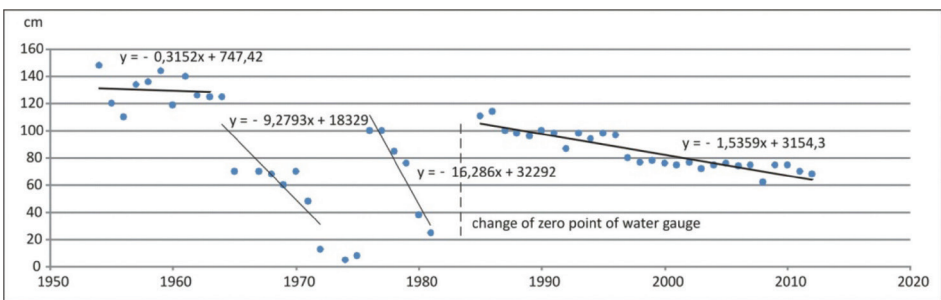
**Figure 3.** Lowering of the minimum annual water stages of the Mszanka River at the Mszana Dolna gauging station as an indicator of incision rates

Stage correction was developed in response to increased channel slope and its rapid deepening after construction of the debris dam at 5.724 km of the river. The strongest deepening occurred in the years: 1964-1972 and in 1976-1981 (Fig. 3). Training works were conducted between these periods, so the values of the minimum stages are incomparable. Each of the training stages comprised the channel narrowing, its straightening and cutting off lateral meanders, which considerably diminished the flow cross-section. The channel along river section trained with drop structures revealed a relative horizontal and vertical stability, whereas it was very unstable below. Problems appeared particularly during flood water flow. Flood water was flowing with a high velocity through the narrowed flow regulation route and strongly eroded the bottom and channel bank. Engineering structures were also damaged during floods. The training conducted to limit erosion did not eliminate the problem but moved it closer to the mouth. Therefore, sometime later a decision was made to train the next section. Finally the stage correction covered the whole length of the Mszanka lower course. However, the problem of erosion remained. The diagram of minimum water stages shows that the tendency for channel deepening lasts continuously in the channel, although the process is less intensive (Fig. 3). Strong erosion occurs in the Raba channel below its junction with the Mszanka. According to the course on minimal annual water stages over the last 100 years at water gauging station

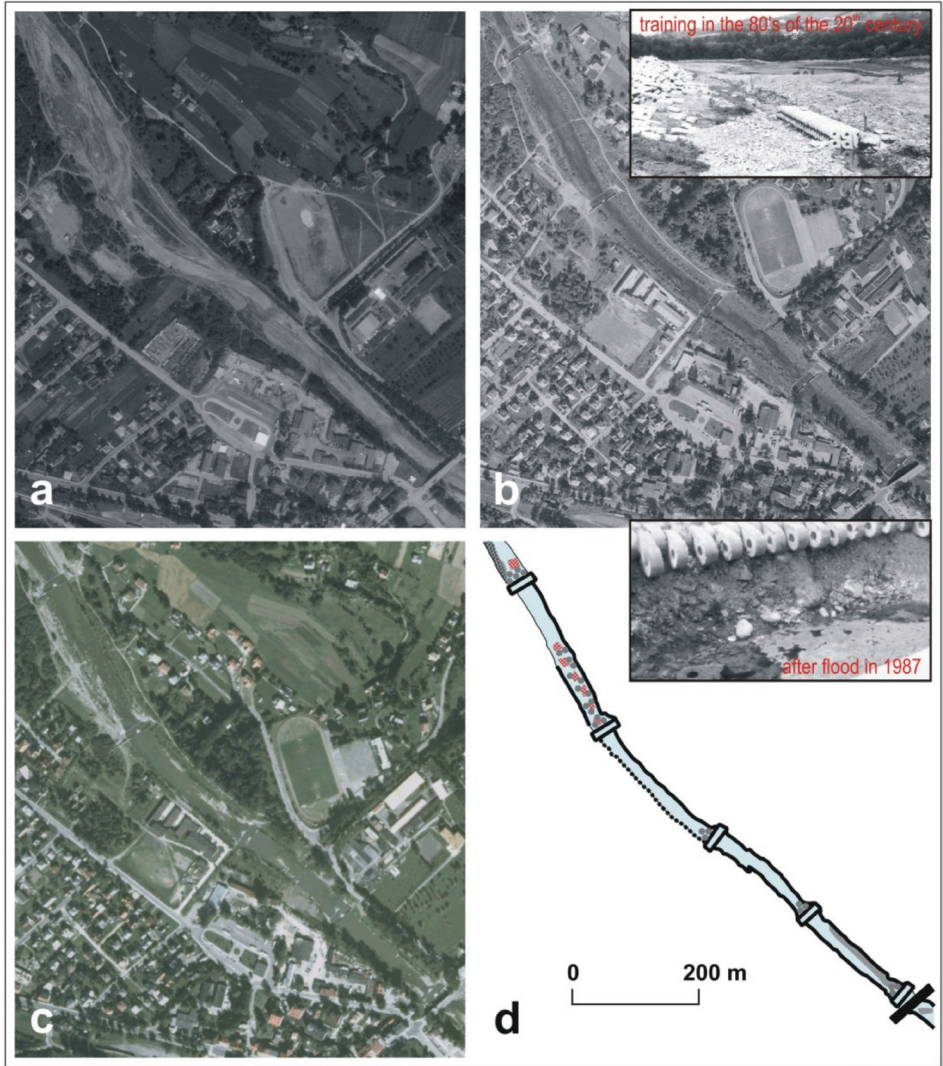
gabion rock mattresses was damaged or totally destroyed and in these places 0.3-1.1m potholes formed. Concrete steps were scoured and 0.2-1.3 m deep potholes were forming below them. Some concrete steps and bank reinforcements were damaged or destroyed (Photo in Fig. 5b).

**Figure 5.** Change of the Mszanka channel morphology at the section regulated during the second period of training: a – 1976, b – 1993 (photographs of the as-built inventory of the flow regulation route acc. to project 4175), c – 1997, d – 2015 (based on terrain mapping). Legend as in Fig. 4.

Numerous bars, visible in the channel bed below the Porębianka mouth were mostly deposited during the flood (Fig. 5c). Many drop structures were partly or wholly covered by the bedload. Concave banks were undercut, which caused their local scouring and destruction of bank reinforcements. Renovation of the analysed channel section (3.928-2.140 km) was carried out in 1998 (acc. to Zestawienie... 2004). Both banks were armoured with concrete prefab bands and the channel was cleared by removing the accumulation forms. Subsequent renovation works were conducted after the flood in 2001.
