## **EVOLUTION OF THE LOWER MSZANKA CHANNEL SECTION AFTER TRAINING USING STAGE CORRECTION METHOD**

***Joanna Korpak***

*Cracow University of Technology*

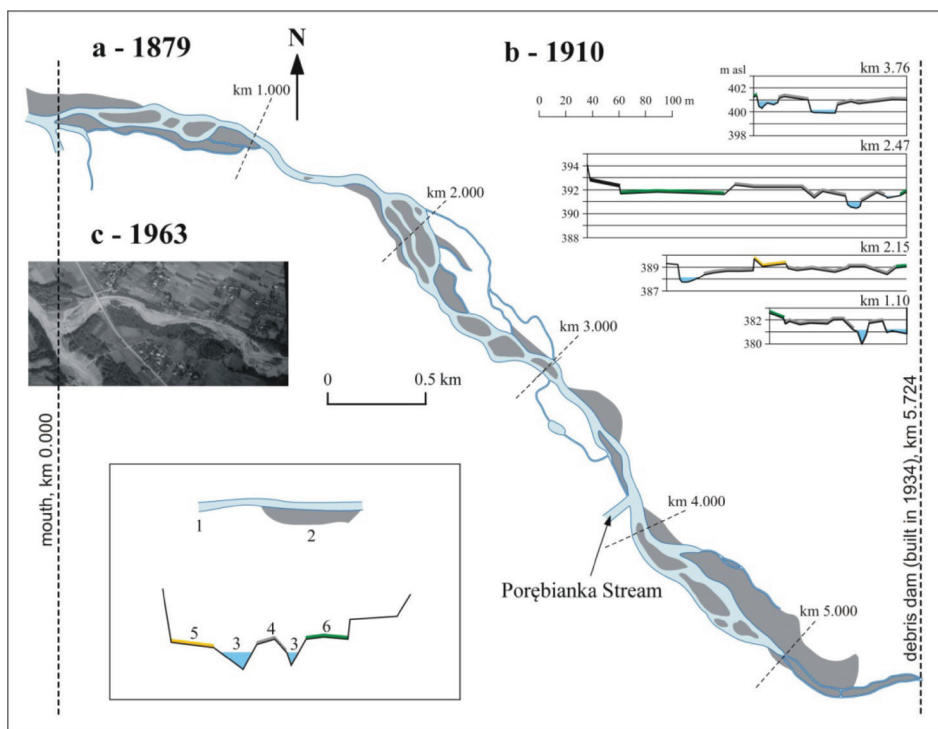
By the end of the 19<sup>th</sup> and at the beginning of the 20<sup>th</sup> century the channel in the lower Mszanka course was braided, alluvial with large central and lateral bars, some of which were utilised as pastures or arable lands (project no 11/90/8, 1910). The channel width exceeded 100 m, in some places reaching even 300 m (Fig. 2a, b). The river loading at this section considerably exceeded its transport ability, as evidenced by the deposition of carried material. Uplifting channel bottom posed a flood hazard for the adjoining agricultural lands. To stave off this problem, a decision was made to construct a debris dam which would arrest the transported material. The project was a part of the plan of systematic channel consolidation along a 12.5 km long Mszanka River reach, developed by the Commission for River Training in Galicia at Imperial-Royal Governorship in Lvov in 1910 (project 11/90/8, 1910). The project was never completed. The dam was constructed in 1934 at 5.724 km of the river in the valley necking. The channel was 20 m wide. The dam, one of the oldest in the Podkarpacie region was a stone structure with a height of 3.3 m. The fishway was situated on the right bank of the river. The dam reservoir capacity was 78,000 m<sup>3</sup>. In the subsequent years the structure was destroyed several times (by floods in 1964, 1970 and 1997) and renovated (the last time in 1999, project no. 1750, 2000). The dam broke the continuity of the fluvial system and divided the channel into two sections, which from that time were developing differently. Deposition dominated above the dam, whereas erosion below. The erosion undoubtedly occurred along about several hundred metres long section, situated immediately below the structure. Such length of the erosive section was suggested by the research on other channels below dams with similar dimensions (Korpak 2007b, Korpak *et al.* 2008). Deposition of material prevailed below this reach, as evidenced by the aerial photograph of 1963 (Fig. 2c). In this place the channel still remained braided, of a smaller width than at the turn of the 19<sup>th</sup> and 20<sup>th</sup> century, but still very wide (up to 160 m). Values of the minimum annual water stages reveal alternativeness of brief aggradation and degradation episode causing that until 1964 the channel at this cross section revealed vertical stability (Fig. 3).

**Figure 2.** Development of the lower section of the Mszanka channel before regulation: a – in 1879 (on the basis of the Austrian topographic map), b – channel cross sections in 1910 (according to the project no. 11/90/8, 1910), c – in 1963. 1 – water, 2 – bar, 3 – channel with water, 4 – bar, 5 – pasture, 6 – shrubs

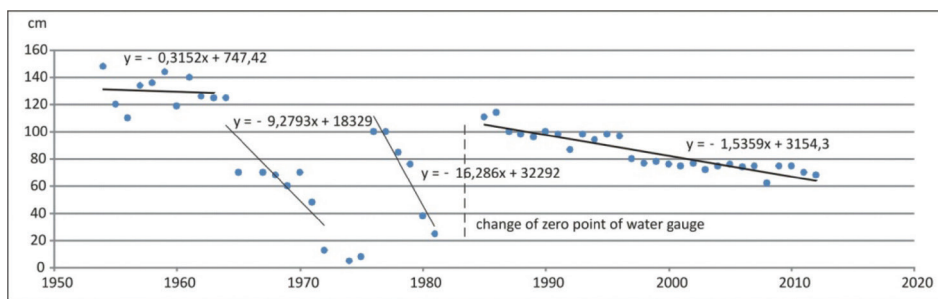
**Figure 3.** Lowering of the minimum annual water stages of the Mszanka River at the Mszana Dolna gauging station as an indicator of incision rates

Stage correction was developed in response to increased channel slope and its rapid deepening after construction of the debris dam at 5.724 km of the river. The strongest deepening occurred in the years: 1964-1972 and in 1976-1981 (Fig. 3). Training works were conducted between these periods, so the values of the minimum stages are incomparable. Each of the training stages comprised the channel narrowing, its straightening and cutting off lateral meanders, which considerably diminished the flow cross-section. The channel along river section trained with drop structures revealed a relative horizontal and vertical stability, whereas it was very unstable below. Problems appeared particularly during flood water flow. Flood water was flowing with a high velocity through the narrowed flow regulation route and strongly eroded the bottom and channel bank. Engineering structures were also damaged during floods. The training conducted to limit erosion did not eliminate the problem but moved it closer to the mouth. Therefore, sometime later a decision was made to train the next section. Finally the stage correction covered the whole length of the Mszanka lower course. However, the problem of erosion remained. The diagram of minimum water stages shows that the tendency for channel deepening lasts continuously in the channel, although the process is less intensive (Fig. 3). Strong erosion occurs in the Raba channel below its junction with the Mszanka. According to the course on minimal annual water stages over the last 100 years at water gauging station

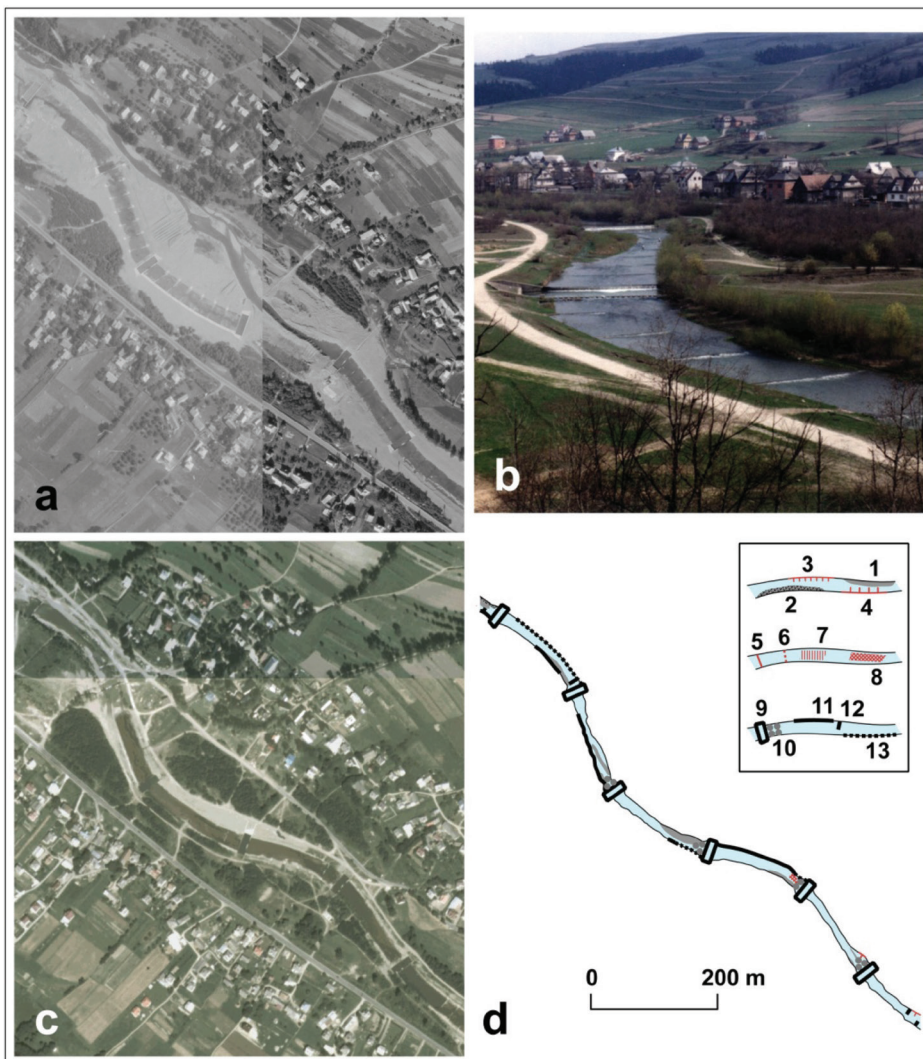
The channel section included in the 1<sup>st</sup> training stage revealed a relative horizontal and vertical stability. Fragments of the former active channel, which were “cut off” due to the training and narrowing, were transformed into a flood-plain and in some place even into a terrace (Fig. 4b).

**Figure 4.** Change of the Mszanka channel morphology at the section regulated during the first training period : a – 1976, b – 1992 (Photo M. Komędera), c – 1997, d – 2015 (on the basis of the terrain mapping). 1 – bar, 2 – vegetated bar, 3 – cutbanks (height >2m), 4 – cutbanks (height 0-2 m), 5 – rocky step, 6 – boulder step, 7 – riffle, 8 – rocky outcrop, 9 – concrete drop structure, 10 – oversized boulders, 11 – embankment of concrete elements, 12 – concrete step, 13 – rip-rap.

Serious changes in the channel morphology were the result of a high flood in July 1997. However, renovation works were conducted immediately in the channel, as may be seen in the aerial photograph taken only a month after the flood. The section from the debris dam to the Porębianka mouth was almost wholly cleared and the banks, especially concave ones, were renovated, which evidences intensive activity of lateral erosion during the flood (Fig. 4c).

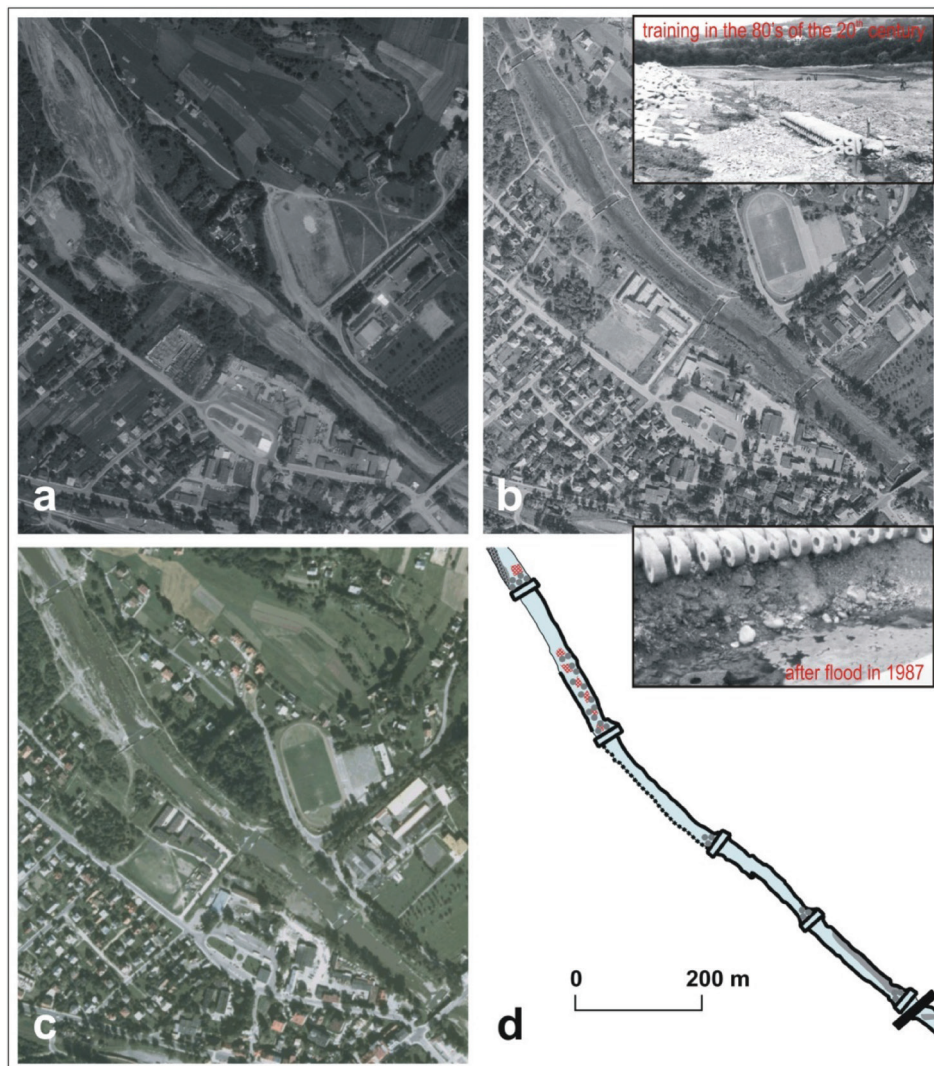
gabion rock mattresses was damaged or totally destroyed and in these places 0.3-1.1m potholes formed. Concrete steps were scoured and 0.2-1.3 m deep potholes were forming below them. Some concrete steps and bank reinforcements were damaged or destroyed (Photo in Fig. 5b).

**Figure 5.** Change of the Mszanka channel morphology at the section regulated during the second period of training: a – 1976, b – 1993 (photographs of the as-built inventory of the flow regulation route acc. to project 4175), c – 1997, d – 2015 (based on terrain mapping). Legend as in Fig. 4.

Numerous bars, visible in the channel bed below the Porębianka mouth were mostly deposited during the flood (Fig. 5c). Many drop structures were partly or wholly covered by the bedload. Concave banks were undercut, which caused their local scouring and destruction of bank reinforcements. Renovation of the analysed channel section (3.928-2.140 km) was carried out in 1998 (acc. to Zestawienie... 2004). Both banks were armoured with concrete prefab bands and the channel was cleared by removing the accumulation forms. Subsequent renovation works were conducted after the flood in 2001.

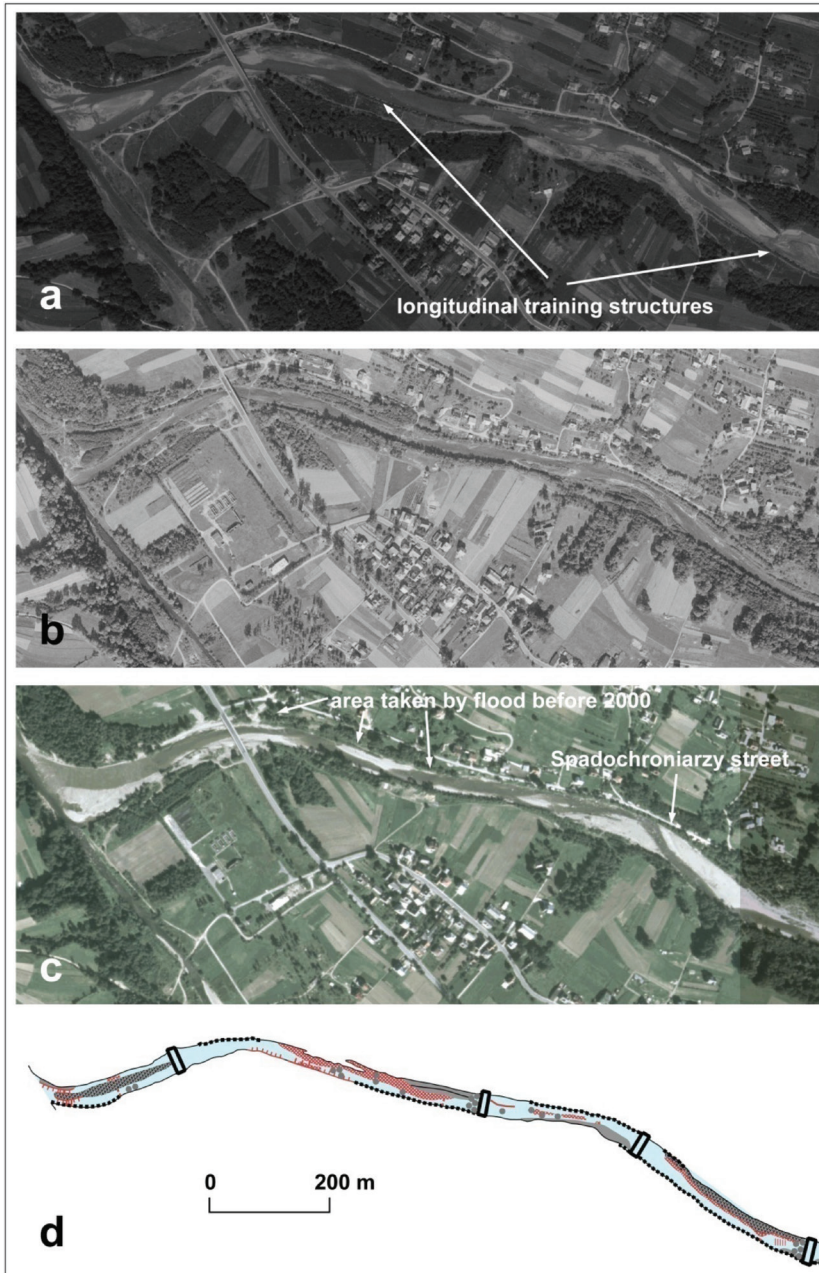
In its final, mouth section, so far not included in training by means of stage correction, in 1993 the channel was single thread and narrow. Its width did not exceed 25 m (Fig. 6b). It was the result of training conducted in the 1970s using groynes and longitudinal dikes.

**Figure 6.** Change in the Mszanka channel morphology at the section regulated during the third period of training: a – 1976, b – 1993, c – 1997, d – 2015 (based on the terrain mapping). Legend as in Fig. 4.

The final, mouth section of the Mszanka River was considerably widened in August 1997 in comparison with its state in 1993 (Fig. 6c). The floodwater, overflowing the artificially narrowed channel, destroyed bank reinforcements.

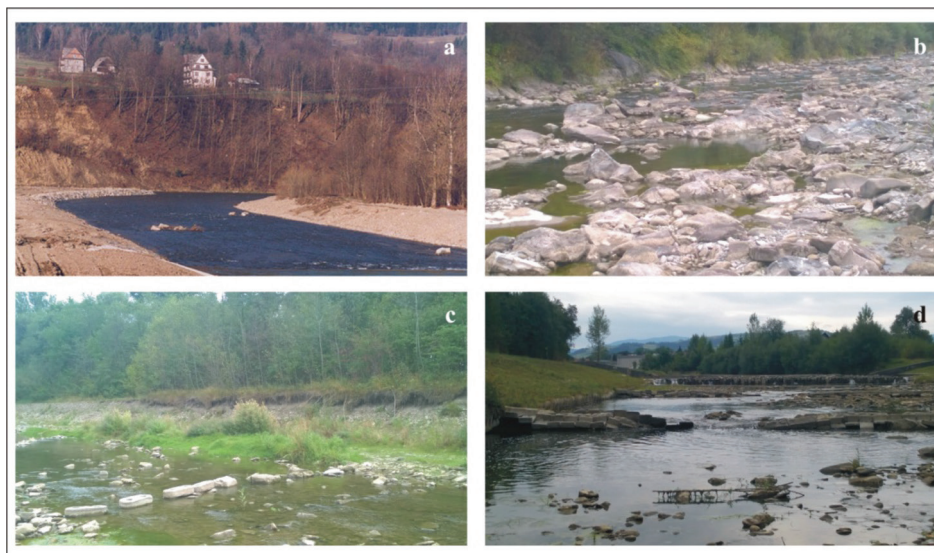
**Figure 7.** Development of the Mszanka channel in 2004 and 2015: a – the channel in 2004 without any fluvial forms after freshly conducted training, b-d erosional channel in 2015: b – rocky outcrops between drop structures, c – cutbanks within the flow regulation route, d – destroyed concrete steps between drop structures

The terrain mapping repeated in 2015 revealed considerable changes in the channel morphology. Along its whole length the river was incised into the bedrock. A thin and discontinuous alluvia layer was present only in some places. Numerous rocky outcrops appeared in the bottom (Fig. 4d, 5d, 6d, 7b). A small, comparable number of bars occurred at each river section, whereas the forms differed considerably with their sizes (Table 1). At the section trained during the first two periods of training, the bars were small and usually lateral (Fig. 4d, 5d). The section regulated in 2003 revealed the presence of large bars, of which the biggest were central forms (Fig. 6d). Big cutbanks appeared at this section (Fig. 7c), as well as rocky steps with an average height of ca. 0.25 m. Few and small erosion forms visible as cutbanks were observed also at the river section closest to the dam. The least of the forms were in the central river reach, which has undergone renovation works in 2013 (City Office Mszana Dolna, 2013). Engineering structures along the whole lower Mszanka section are damaged or even destroyed. It refers particularly to the bank reinforcements, which slide and fall

into the river. Almost all concrete steps constructed between the drop structures were removed (Fig. 7d).
