CHARACTERISTICS OF ILLEGAL DUMPING SITES – CASE STUDY: WATERCOURSES

Mateusz Malinowski, Katarzyna Wolny-Koładka, Bartłomiej Jastrzębski
University of Agriculture in Krakow

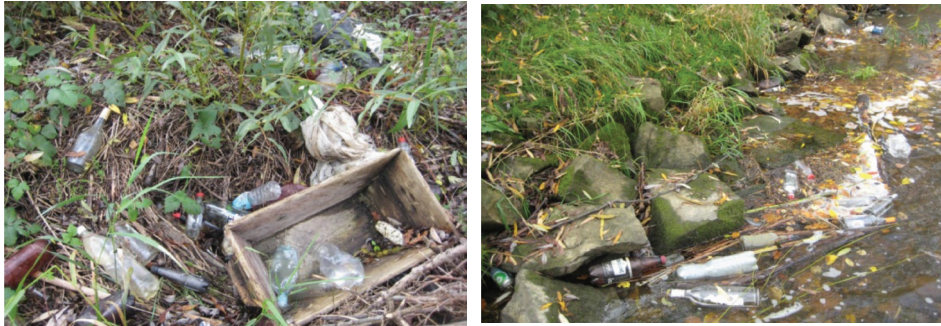
26 illegal dumping sites with a total area of about 373 m² were found on the investigated terrain (Fig.1). The largest illegal dump covered the area of 60 m² and the smallest registered dumping site was 3.5 m². 55 bags of 120 dm³ with waste from 13 illegal deposition sites were collected during the first measurement, while during the second 17 bags were gathered from 7 illegal waste disposal sites (including 6 new ones and 1 located on a previously cleaned terrain), and the third measurement yielded 19 bags of waste from 6 dumping sites (including 5 new ones and 1 located on previously cleaned place). Identified illegal dumping sites were localised directly in the watercourse (the waste were stopped by branches or stones) or on a slope in the river channel (Fig.1). Only the first measurement revealed four cases of illegal dumping sites located on a flat terrain, at the distance of 15-30 metres from the riverbed. Among the 26 identified unlicensed dumping sites, 20 were well visible from a distance.

Figure 1. Illegal dumping sites located on the Wisłok river stretch
