TECHNICAL CONDITION ASSESSMENT OF HISTORICAL BUILDINGS – FLOWCHART DEVELOPMENT

Justyna Jaskowska-Lemańska, Daniel Walach, Joanna Sagan
AGH University of Science and Technology

Abstract

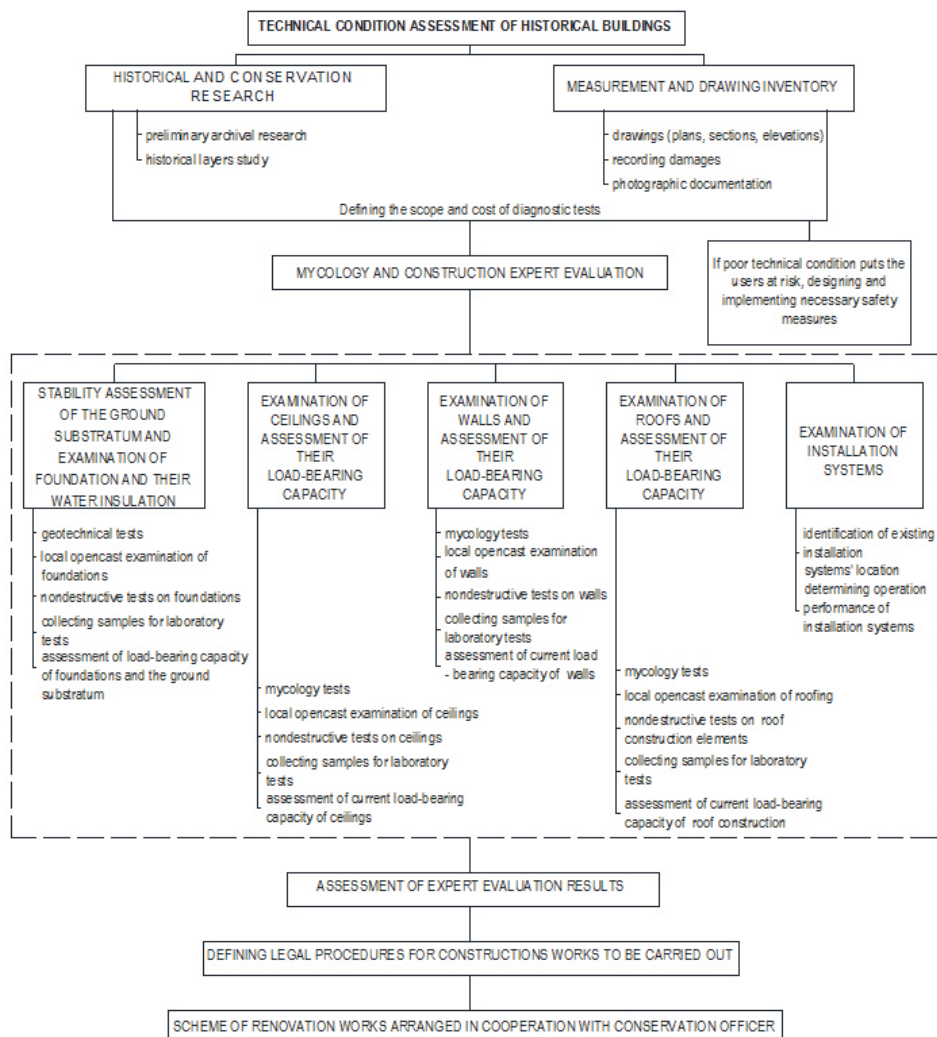
Figure 7. Flowchart of technical assessment procedures for historical objects

Based on tests and examination executed at the Gorzanów palace complex, observations of restoration works carried out there and literary resources, the following flowchart of technical assessment procedures for historical objects and determining damage causes was developed (fig. 7). In the future, the scheme presented here may help, among others, experts in conducting evaluation of technical condition.

An analysis of the flowchart (fig. 7) justifies the conclusion that a technical condition assessment of a building is a complex, interdisciplinary task requiring the involvement of a whole group of experts. Therefore, those who attempt to save or modernize historical buildings, especially severely damaged ones, may follow the tips presented below, which will facilitate considerably in implementing the correct order of activities.
