CHARACTERISTICS OF ILLEGAL DUMPING SITES ON THE EXAMPLE OF THE TRZEBINIA MUNICIPALITY

***Kornel DUDEK¹, Stanisław BODZIACKI¹,
Arkadiusz BIESZCZAD¹, Mateusz MALINOWSKI¹***

ABSTRACT

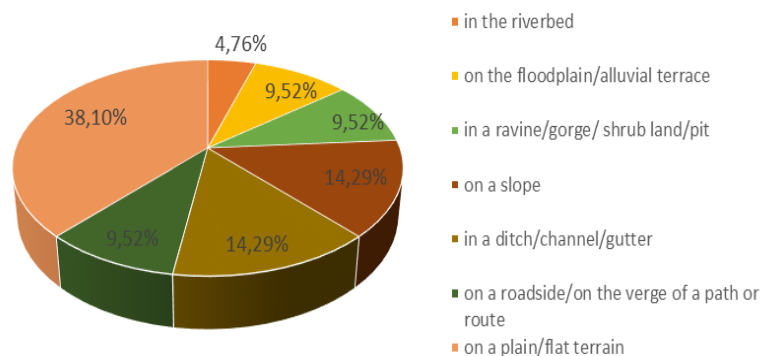
Figure 3. Location of illegal dumps in the Trzebinia commune.

In the Trzebinia commune, 21 illegal waste dumps were located (Fig. 2), all in the southern part of the commune. No hazardous waste was identified in any of the examined illegal landfills, including: medicines, light bulbs, paints, greases and oils. Most illegal dumps are located on flat or even terrain (38.1%). Ditches, canals and slopes took second place in terms of the frequency of wild dumps, accounting for 14.3% of the areas examined (Fig. 3). In most cases, landfills were invisible, most often hidden in clumps of bushes and in the forest.

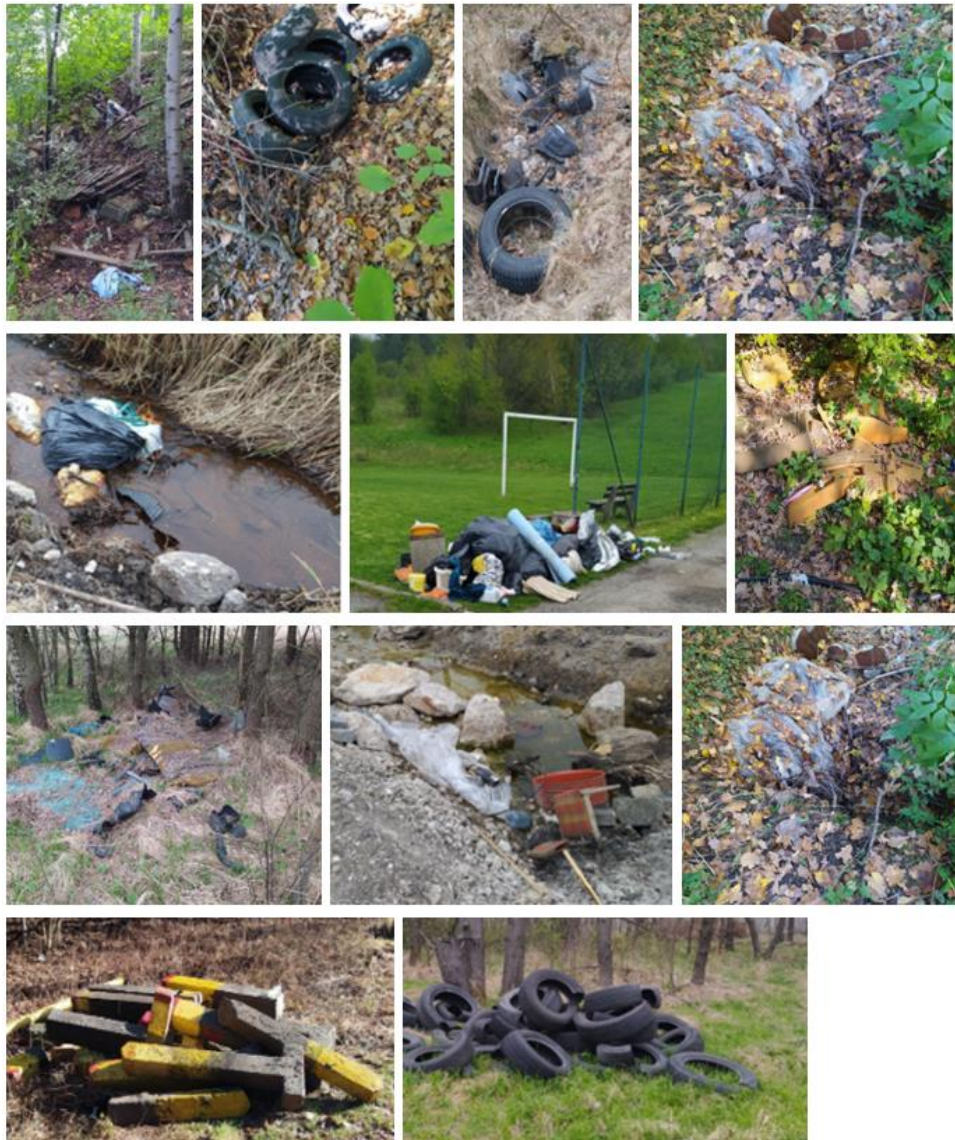
Figure 10. Inventoried illegal dumps in the Trzebinia commune.

Figure 10 shows photos of selected illegal garbage dumps in the Trzebinia commune. The results of the analyzes partially confirm the observations of Zabłocki *et al.* (2011) and Malinowski *et al.* (2015), who found that small illegal landfills mainly deposit PET bottles (polyethylene terephthalate), glass bottles and metal cans, while larger landfills contain rubble (construction and renovation waste).
