Piotr Herbut

AIR MOVEMENT CHARACTERISTICS INSIDE A COW BARN WITH NATURAL VENTILATION UNDER NO-WIND CONDITIONS IN THE WINTER SEASON

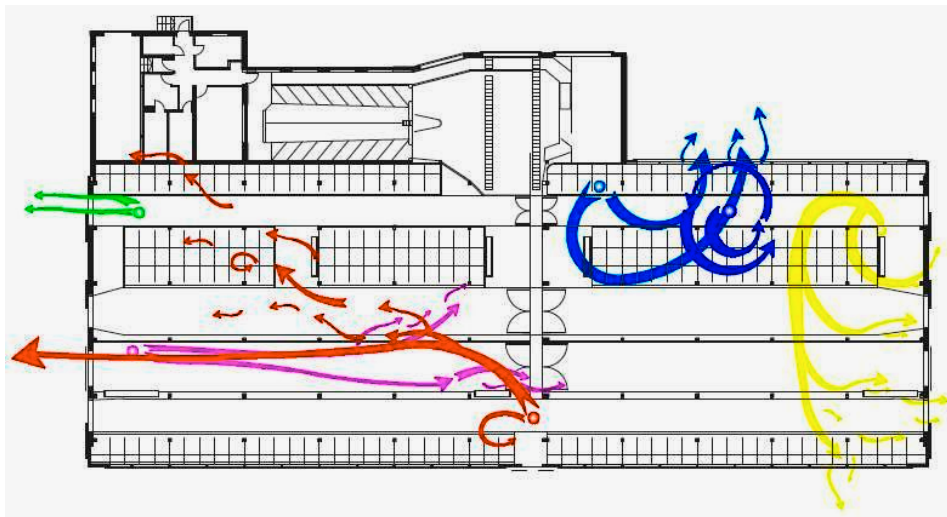
Under no-wind conditions and with curtain walls and entrance doors wide open (wind velocity lower than $0.5 \text{ m}\cdot\text{s}^{-1}$), the air moved along longitudinal corridors of the barn (marked in red and purple). In the vicinity of stalls and the manure corridor, certain smoke turbulences appeared (marked in blue and navy blue) (figure 3 and 4). At the north-western wall, some of the smoke (marked in yellow) moved across the cow barn between the open curtain walls and got out of the building through openings in the gable wall (figure 3 and 4). The observed air movement occurred most of all above the occupied zone (just below the ceiling), which points to the lack of suitable barn ventilation system.

Figure 3. The movement of smoke from smoke generators in six characteristic points of the main hall with curtain walls wide open – an overview
