*Marta Łapuszek*

## **STUDIES ON RIVERBED EVOLUTION ON THE NIDA RIVER AT THE PIŃCZÓW AND WIŚLICA GAUGING STATION**

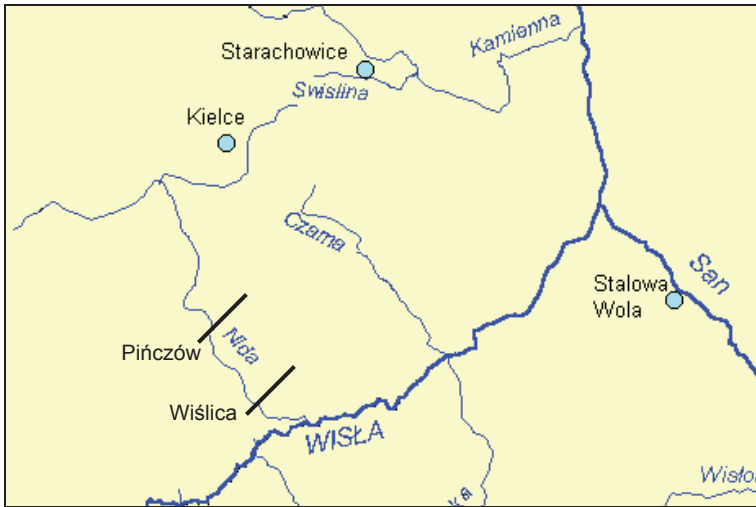
**Figure 1.** The Nida River basin and locations of the analyzed gauging stations on the Nida River

The Nida River, with a total length of 151.2 km, and the basin area of 3865 km<sup>2</sup>, is the largest left-bank tributary of the Upper Vistula River. The outlet of Nida is located at the 175.4 km of the Vistula course. The sources of Nida are in the vicinity of the city of Szczekociny within the Płaskowyż Jędrzejowski at 268 m above sea level. The river is formed from the Biała Nida and Czarna Nida rivers. In Żerniki, Biała Nida joins its left-bank tributary, Czarna Nida, and changes its name to the Nida River. The total length of the hydrographic network in the Nida River basin network is 3900 km. The studied area is located in the mid- and lower sections of the Nida River (see Fig. 1).

The studies on river bed evolution were carried out for two gauging stations: Pińczów and Wiślica (Fig.1). For the Pińczów gauging station the period of 1947-2009 was analyzed; for the Wiślica gauging station the period of 1940-1991. Collection of observation data at Wiślica ceased in 1991 and the station was later removed. The sequences of data contain interval of discontinuity (1961-1970). This is due to the lack of recorded observations. However, the observation period of time guarantees sufficient amount of data for a good analysis of variability of the river bottom level over time. Moreover, evaluation of the process and progress of river bottom erosion, based on data from past years documents the changes that occurred in the river channel.
