TECHNICAL CONDITION ASSESSMENT OF HISTORICAL BUILDINGS – FLOWCHART DEVELOPMENT

Justyna Jaskowska-Lemańska, Daniel Walach, Joanna Sagan
AGH University of Science and Technology

Abstract

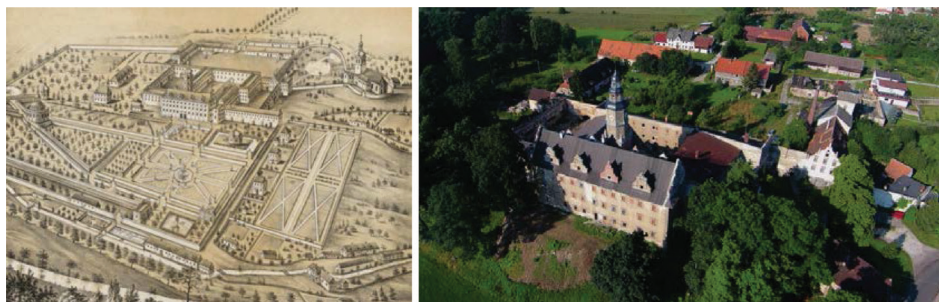
Figure 1. Panoramic view of the palace complex in Gorzanów from 1738 (left) and 2014 (right)

In 1573, a renaissance palace complex was erected in Gorzanów funded by Johann Friedrich von Herberstein. In the years 1653 to 1657, the monumental

palace was modernised and partly rebuild in the baroque style. The palace and park complex in question represent the *entre cour et jardin* type (fig. 1).

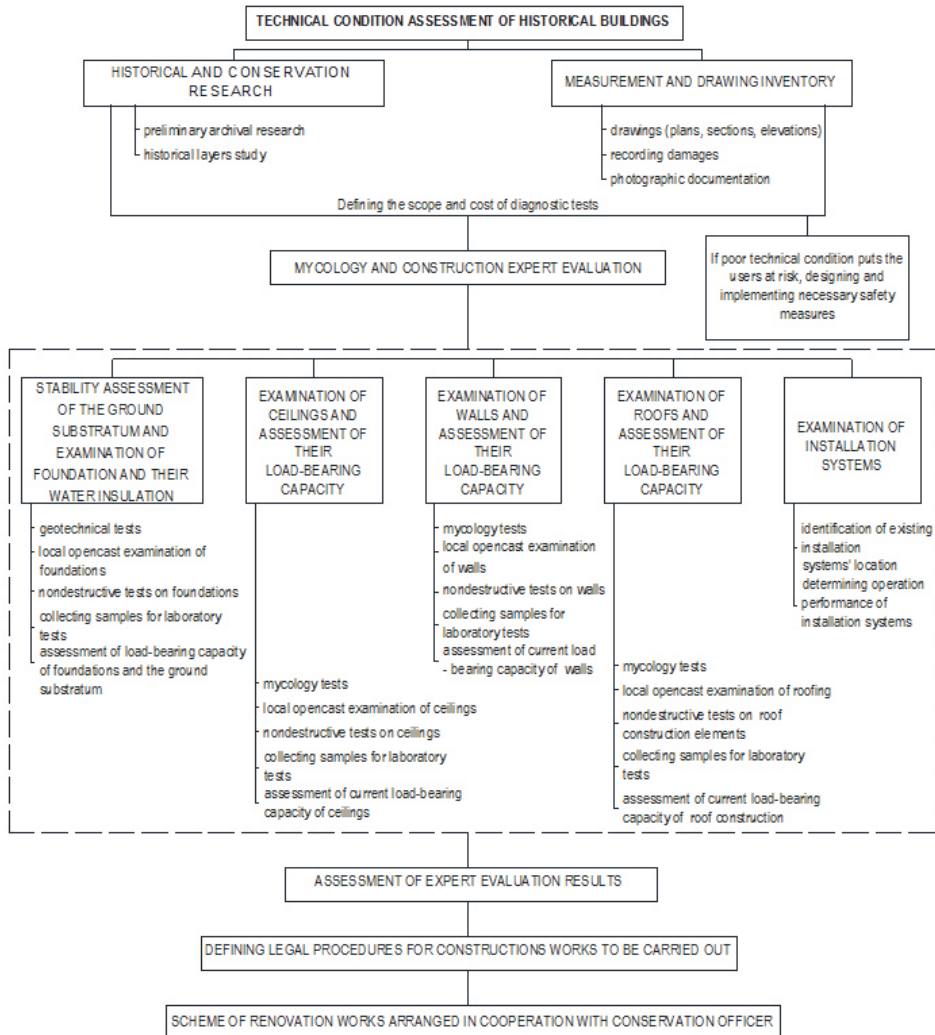
Figure 7. Flowchart of technical assessment procedures for historical objects

Based on tests and examination executed at the Gorzanów palace complex, observations of restoration works carried out there and literary resources, the following flowchart of technical assessment procedures for historical objects and determining damage causes was developed (fig. 7). In the future, the scheme presented here may help, among others, experts in conducting evaluation of technical condition.

An analysis of the flowchart (fig. 7) justifies the conclusion that a technical condition assessment of a building is a complex, interdisciplinary task requiring the involvement of a whole group of experts. Therefore, those who attempt to save or modernize historical buildings, especially severely damaged ones, may follow the tips presented below, which will facilitate considerably in implementing the correct order of activities.
