ANALYSIS OF MORPHOLOGICAL COMPOSITION OF WASTES DEPOSITED ON ILLEGAL DUMPING SITES LOCATED IN THE AREA OF OLSZTYN DISTRICT

Dominika Ciura, Maria Łukasiewicz, Mateusz Malinowski
University of Agriculture in Krakow

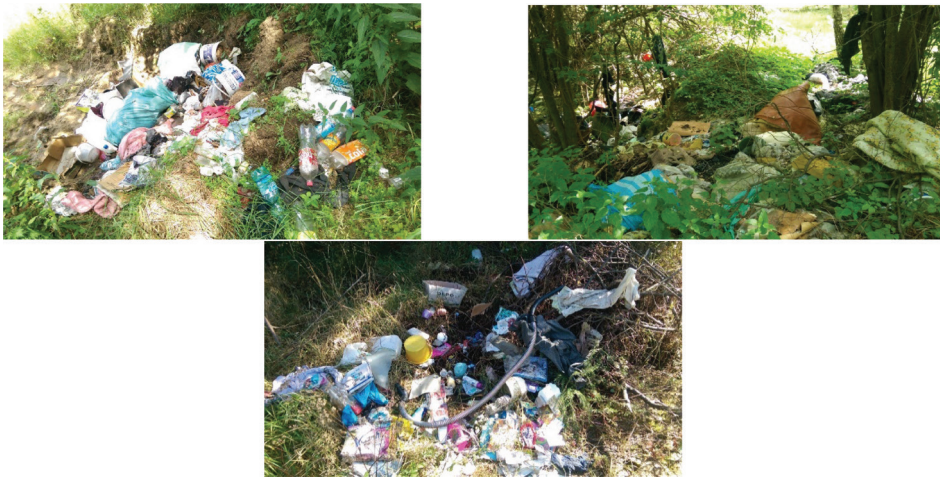
Figure 4. Selected illegal dumping sites located in the area of Olsztyn district

well as wall paints, varnishes and solvents (13.4%). Figure 5 shows the photographs of selected illegal landfill sites in Olsztyn district.

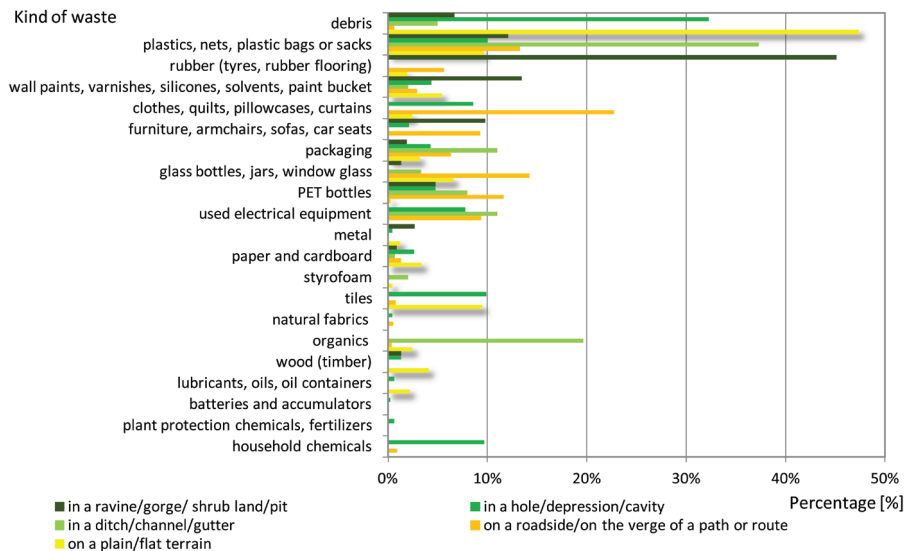
Figure 5. Morphological composition of wastes deposited on illegal dumping sites versus their localization in the area

Morphological composition of the wastes deposited on illegal dumping sites in relation to their localization differs between the individual types (Fig. 4). Debris is deposited mainly on flat terrains, in holes and in cavities, respectively (47.4% and 32.3%). Plastics, plastic bags and nets (37.3%) and organic wastes dominate in ditches and channels. The composition of wastes deposited in ravines and gorges is disturbing, as it reveals mainly rubber wastes (45.1%), as

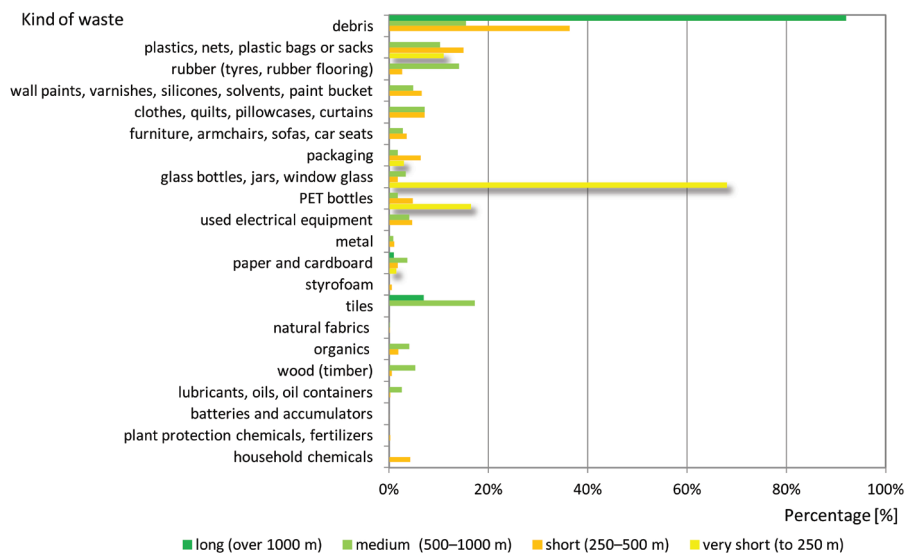
Figure 7. Morphological composition of wastes deposited on illegal dumping sites versus their distance from buildings

It was found that morphological composition of wastes differs in relation to the distance from buildings. Illegal dumping sites situated closest to buildings (less than 250 m) contained mainly packaging (potential recyclable materials)

suitable for recycling. The dominant are: glass (68.0%) and plastics, i.e. PET bottles (16.5%), plastics and nets (11.0%), as well as other packaging (3.0%), paper and cardboard (1.5%). Morphological composition of wastes on illegal landfill sites located at the distance shorter than 500 m, contained the highest proportion of debris (36.4%), followed by plastics and plastic bags (15.0%). No kind of waste dominated on illegal dumping site situated at the distance of between 500 and 1000 m from buildings. Comparable shares of construction wastes, like tiles (17.3%) or debris (15.5%), but also rubber wastes (14.1%) or plastics (10.3%) were registered. The landfills situated furthest from buildings, more than 1000 m, contained mainly debris, which made up over 90% (Fig. 7).
