INFRASTRUKTURA I EKOLOGIA TERENÓW WIEJSKICH INFRASTRUCTURE AND ECOLOGY OF RURAL AREAS

CHARACTERISTICS OF THE TEMPERATURE AND HUMIDITY CONDITIONS IN A DEEP-LITTER BARN IN A SUMMER SEASON

Grzegorz Nawalany, Paweł Sokołowski

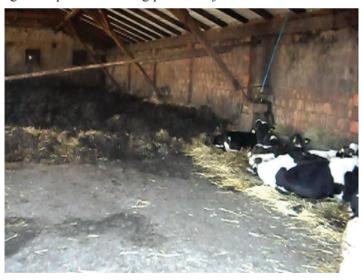
Figure 1. The inside of the analysed object (Photo P.Sokołowski)

The analysed object was a deep-litter barn for 50 dairy cows (Fig.1). The building is situated in Kuchary village in the Świętokrzyskie voivodship.

The analysed building is north-south oriented with its longitudinal axis. It has been constructed using traditional technology. Its concrete foundations are at the depth of 120 cm below the ground level, the barn external walls are made of perforated ceramic bricks (MAX type), the queen post truss roof is covered with troughed sheet. The ventilation system with ridge apertures has been applied in the building and a parallel milking parlour adjoins the barn.

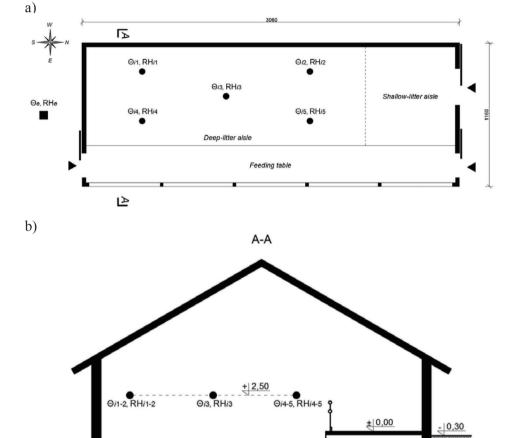
Figure 2. Location of the measurement points of: indoor air temperature $(\Theta_{i_{1-5}})$, relative indoor humidity $(RH_{i_{1-5}})$ and the ambient air temperature (Θ_e) and relative humidity (RH_e) ; a)projection, b)cross-section

The measurement of indoor temperature and relative humidity was conducted in 5 measurement points, whereas the measurement of the ambient temperature and relative humidity was made in one point (Fig.2).

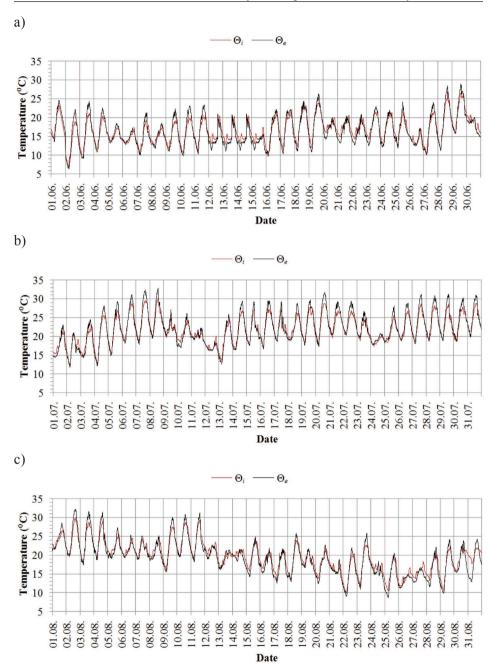
Figure 3. The course of indoor air temperature (Θ_i) and the ambient temperature (Θ_e) in the months of: a) June, b) July, c) August

The course of the indoor air temperature (Θ_i) and ambient air temperature (Θ_e) were presented in Figure 3. At the initial stage of the investigations (June) the indoor temperature oscillated within the range between 17 and 18°C at night and 22-23°C during the day. The indoor air relative humidity was on the level of about 75%. 30 cm thick litter was spread in the barn (June) and supplemented in the subsequent months. In August its thickness was about 45 cm. Free-range dairy herd husbandry was conducted in the barn, which denoted that for a major part of the day the animals remained outside the barn – on the pasture. During the investigated summer periods cows were in the building only during the morning milking (ca. 7:00) or under unfavourable weather conditions. The building remained open all the time to allow the animals a free movement. This solution caused that the barn was well aired and the indoor temperature Θ_i was approximate to the ambient temperature Θ_e .

Despite intensive ventilation of the barn, on hot days it was impossible to lower the indoor air temperature below the thermal stress temperature. In June the recommended maximum indoor air temperature (>25°C) was exceeded only for three days. However, these were only brief raises in the temperature, totally constituting only about 1% of the whole month. In July raised temperatures were registered on as many as 24 days (total period with elevated temperature was 23% per month), whereas in August for 10 days (9% in the scale of the month).

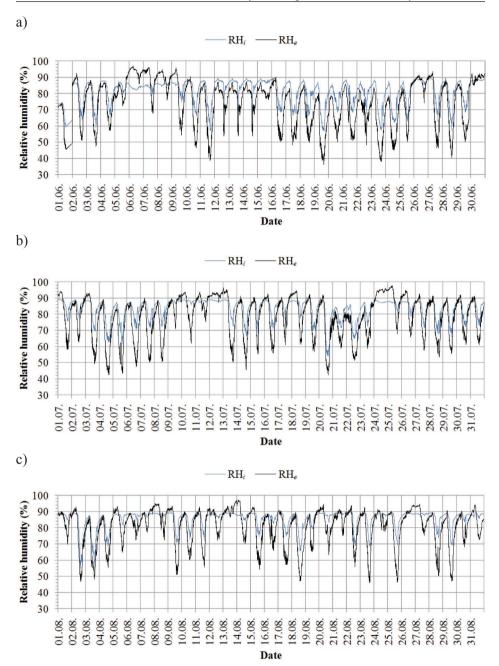
Figure 4. The curse of indoor air humidity (RH_i) and ambient air humidity (RH_e) in the months of: a) June, b) July and c) August

Figure 4 shows the course of the relative indoor air humidity and relative ambient air humidity in the summer months of animal rearing.

The research revealed that during the summer period the maximum value of relative indoor air humidity (RH_i) was also exceeded in the researched barn. The period when the permissible value of exceeded indoor air relative humidity was registered in each of the analysed months. The most unfavourable conditions occurred in August, when the indoor air relative humidity reached even 90%.

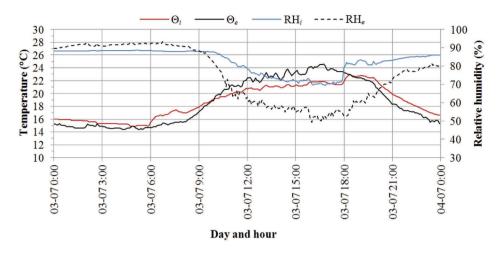
Figure 5. The course of temperature and relative humidity of indoor and ambient air on 3rd July, 2014.

The course of the temperature and relative humidity of the indoor and ambient air for the selected period were presented in Figure 5.

Analysis of the daily course of the temperature and indoor air relative humidity demonstrated that such brief stay of the animals in the building has a slight effect on the indoor temperature changes in the barn. During the morning milking (ca. 7:00), cow entering the barn caused a raise in the air temperature by ca. 2.5°C, whereas during the evening milking the temperature inside the barn increased by ca. 1.5%. A definitely greater dynamics of changes was observed in case of the indoor air relative humidity, which in result of cows entering the barn raised by ca. 10%.
