THE GROUNDWATER LEVEL CHANGES CAUSED BY MODERNIZATION OF WATER DEVICES IN THE POMORZE FOREST DISTRICT

Abstract

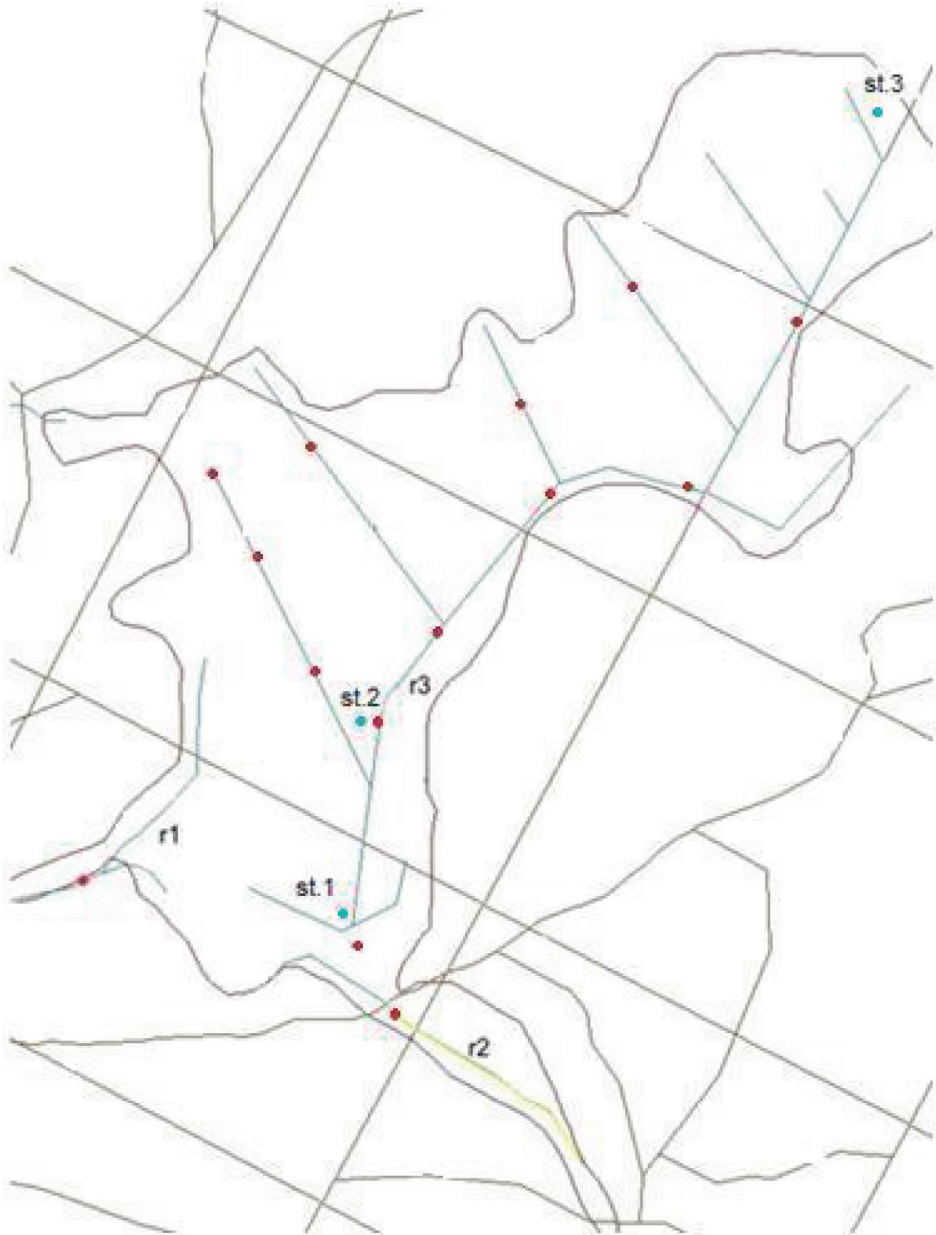
Figure 1. The location of measurement wells (●), and retention objects on the facilities (●).

The investigated facilities comprise regular drainage ditches system of a total length of approximately 4000 m. The drainage ditches system was made on a flat terrain of small land slopes. First the main ditch r3 was a tributary of ditch r1. However, ditch r3 is not connected to ditch r1 (fig. 1). Therefore, it has to be treated as a contained one. 13 dams of wood-earth construction, each of damming height of 0,65 m and frame width of 3 m. What is more, a pond for amphibians of 1000 m² area and a stone weir of damming height of 0.7 m.

The condition of infrastructure of the facility shows that dams generally are in a good condition. No damage or leakage was found. Their upper part is covered with vegetation and uncovering it shows that the wooden construction is with no significant damage. Sand pack and rip-rap are also in good conditions and no significant damage was found. The construction seems solid and resistant to mechanical damage. In comparison to dams, the conditions of ditches is worse. Over the entire length of ditches running on the boundary between forest and meadow (ditch r3 between wells st.1 and st.2), heavy scrub encroachment and their local shallowing has been observed. This results in a significant reduction of the possibility of water flow in these sections. Those ditches are characterized by a high depth variability which is from a few to several centimeters. Clear ditch channels are found in wooden land where dams are also found (fig. 1).
