A TECHNICAL ANALYSIS OF BARNs ON LARGE DAIRY FARMS IN NORTHERN POLAND

Abstract

Keywords: barn, maintenance systems, technical solutions, dairy cattle

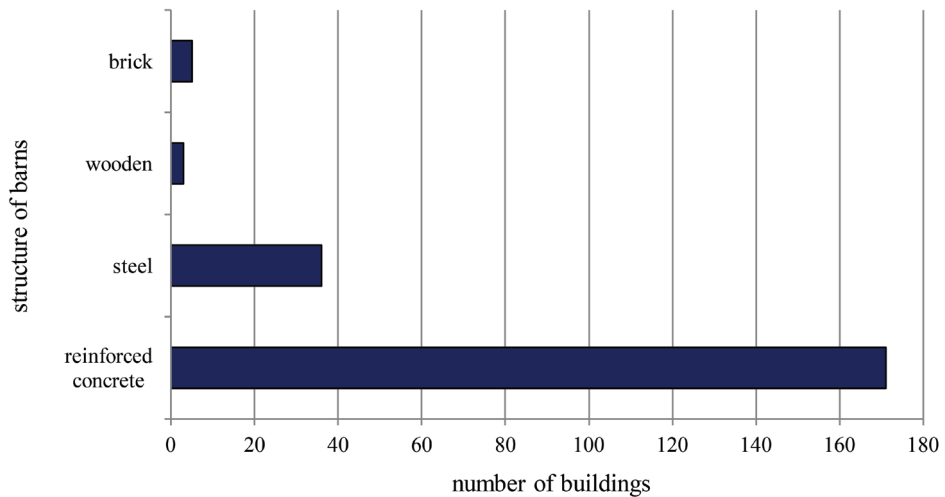
Figure 4. Structure of barns

A great majority of existing dairy farms operate based on the former state-owned agricultural holdings, which were bought by companies or private owners. For this reason, the existing, most common barns of Fermbet or Fermstal type with individual modifications have been modernised and adjusted to valid standards in the last decade. In contrast, newly constructed barns usually have a steel structure (Figure 4).

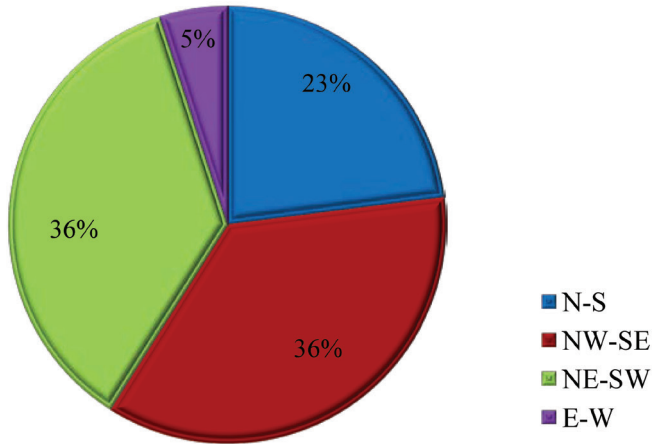
Figure 5. Barn longitudinal axis orientation towards the cardinal points

The orientation of the barns towards cardinal points is significant for gravity ventilation efficiency and disadvantageous sunlight exposure of the building during the summer. Figure 5 presents the distribution of barn orientations, more specifically barn longitudinal axis orientations.

- the designing of new dairy cattle farms must take into account the optimization of the barn location with respect to directions of the world.

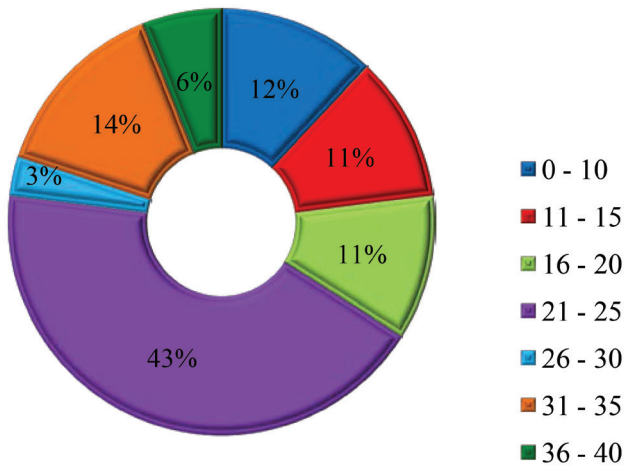
Figure 6. The number of cows milked at once in the milking parlour in the analysed dairy farms

The milking centre is the heart of the dairy farm, affecting cow welfare, milking time and work comfort of the staff. Milking time depends mostly on the number of cows to be milked and on the type of milking parlour (Figures 6 and 7).

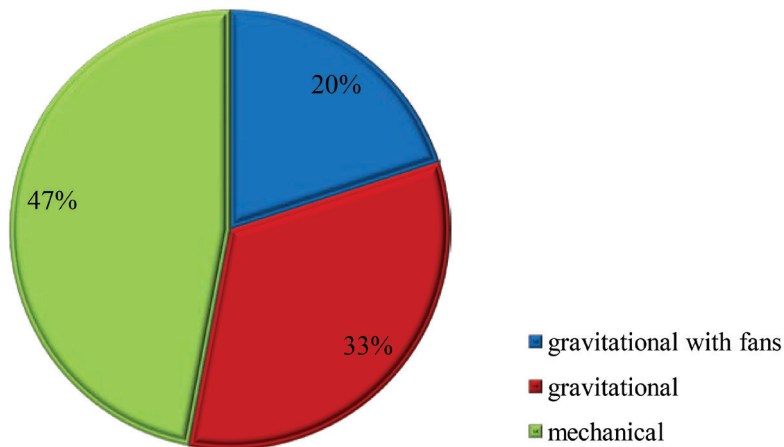
Figure 8. The shares of ventilation systems in the milking centres

Since, in the milking centre, a relatively large number of cows are gathered in a small space, the internal ventilation should be exceptionally efficient in order to reduce cow discomfort. Figure 8 presents the shares of different ventilation systems in the milking centres under analysis.
