## **THE IMPLEMENTATION OF IRRIGATION SYSTEM IN TANZANIA UNDER DEVELOPMENT AID PROJECT CONDITIONS**

### ***Summary***

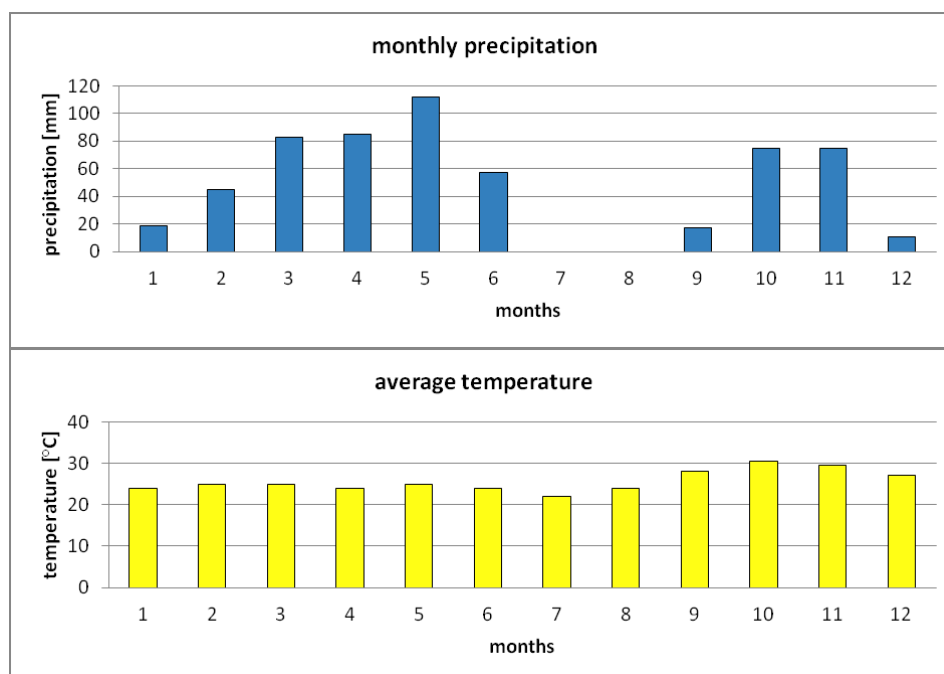
**Figure 2.** Monthly precipitation and average air temperature measured on meteorological station Tengeru in 2011

Meteorological data (rainfall [mm], temperature [°C]) were measured on Tengeru Meteorological Station. Station no 9336035 is located at a latitude 3:23:00 S, longitude 36: 52 E, and altitude 1280 m. Monthly values of precipitation and air temperature measured in 2011 are shown in Fig. 2.

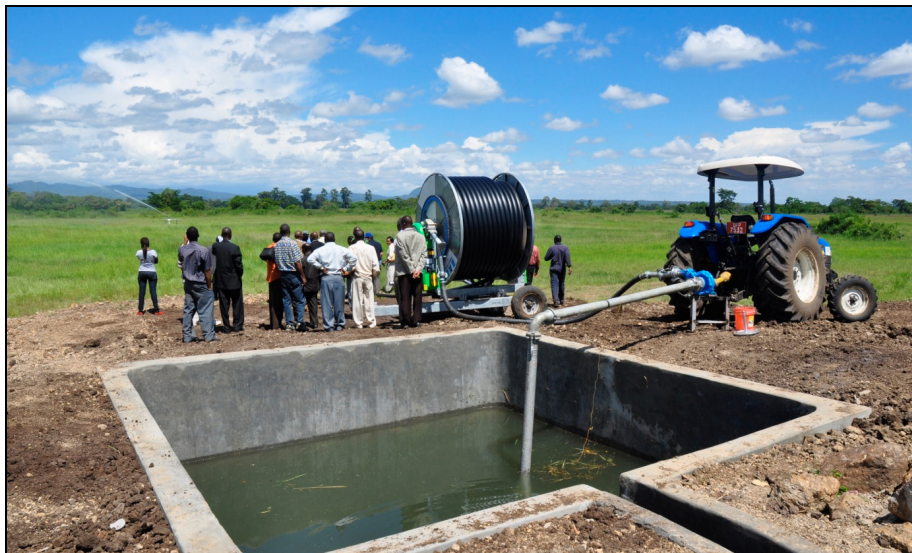
**Photo 1.** Basic elements of II stage of implemented irrigation project (water reservoir, tractor operated pump and hose reel irrigator)

The sprinkler irrigation system implemented under the project in 2012 was the continuation of previous activities carried out in 2010. As part of the project, implemented in 2012, two hose reel irrigators made by Bauer company - smaller model Rainstar A3, and bigger model Rainstar T41, with supplying them an engine driven tractor water pump were purchased and installed. The hose reel irrigators are supplied with water stored in small concrete reservoirs. Four square, concrete water reservoirs with a capacity of 50 m<sup>3</sup> each and one reservoir of circular cross section and a capacity of 80 m<sup>3</sup> were constructed as the part of the project. Small water reservoirs are supplied with water from a large earth construction reservoir, built in 2010. Small reservoirs construction was co-financed by the Ministry of Foreign Affairs RP and LITA Tengeru. The effect of the work carried out in the project made sprinkling irrigation for the meadow land area of about 30 hectares possible. In accordance with the project the commissioning and operations of sprinkler irrigation system have helped to reduce the deficit of water in the soil profile and to ensure favorable conditions for plant growth, which have led to increase in field of hay per hectare gained from both the field and unit growth in the number of hay cuts. The LITA Tengeru staff has been trained in the use of irrigation system. The implementation of the task allowed for obligatory inclusion of any additional operation rules of that kind of system to the teaching program conducted in LITA Tengeru.

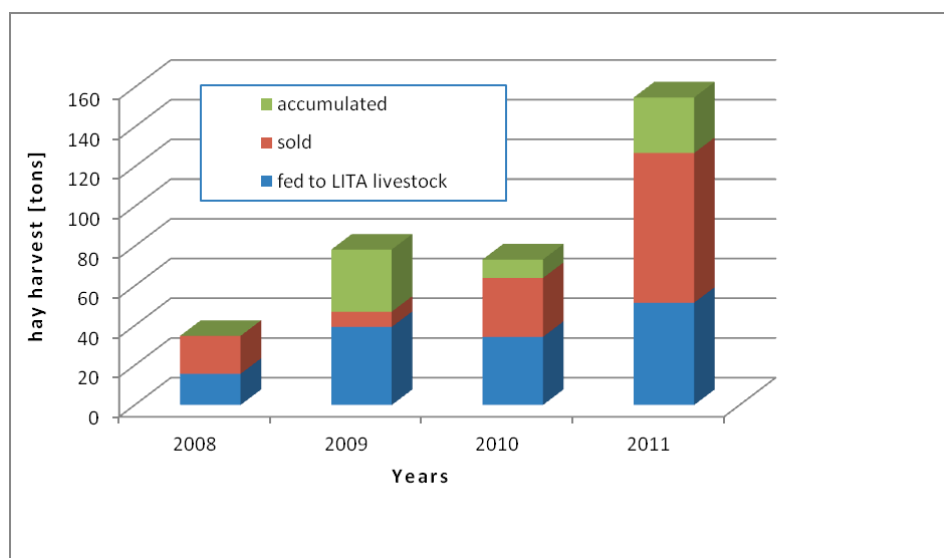
**Figure 5.** Hay harvested in Tengeru in period 2008-2012

As a result of two development projects implemented in Tengeru in 2010 and 2012 the mobile irrigation system for irrigating about 35 ha of grasslands was designed, built and set in. The implementation of the irrigation system allowed for a significant increase in the production of hay. In the analyzed time period (from 2008 to 2012) the increase in yields of hay from 34.7 tons to 237.3 tons was noticed. It also managed to get an increase in the number of cuts from one in 2008 to three in next year. The increase in harvested crop of hay helped to meet the needs of LITA in animal feeding, accumulation of feed and the sale of surplus hay in the coming years. Total yield of harvested hay, taking into account and accumulation of sale, is shown in Fig. 5. The resulting implementation of the irrigation project increase in hay production should be considered valuable, especially in the conditions of advancing climate change and its potential impact on the reduction of agricultural production in Tanzania (Rowhania et al., 2011).
