## **USAGE OF AN EMPIRICAL EQUATION FOR DETERMINATION OF MEAN SEDIMENT DIAMETER IN BEDS OF SMALL MOUNTAIN RIVERS**

*Anna Lenar-Matyas, Andrzej Wolak*  
*Krakow University of Technology*

**Keywords:** mean sediment diameter, empirical formula, check dam

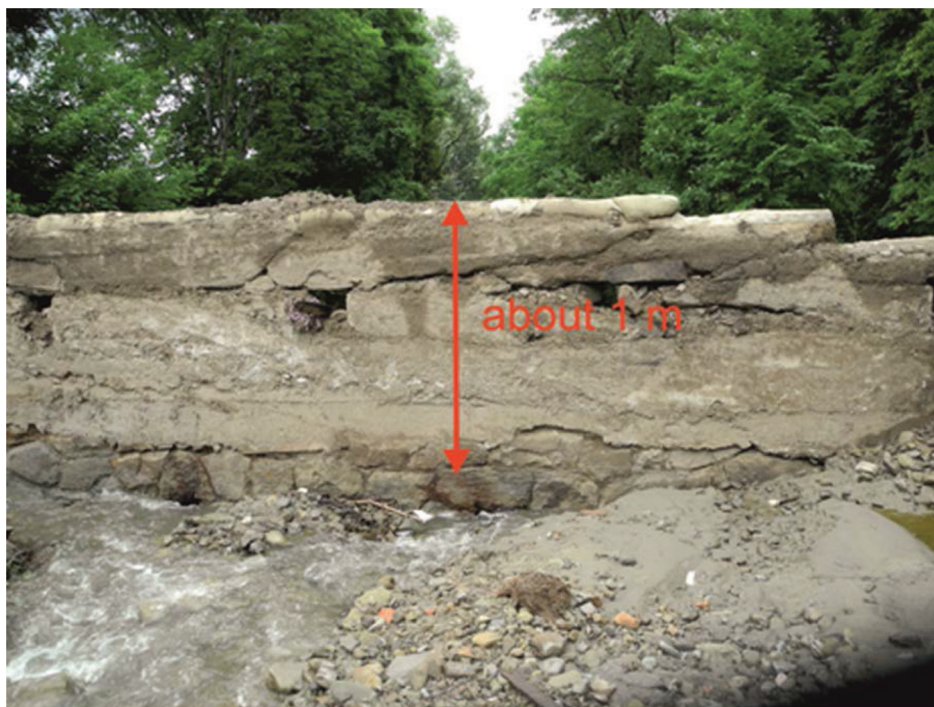
**Figure 1.** Heightened part of the dam, as seen while emptying of the reservoir

The Trzebuńka river dam was built in 1935 to create a head for small hydroelectric power plant. In the eighties of XX century the plant was removed, the section of the river was rebuilt and stabilized, the dam itself was heightened by approximately 1m (Figure 1). Its main purpose was also changed into sediment accumulation and means of stopping of riverbed erosion upstream. The height of the structure was approximately 4m, with stone slabs (partially) as cladding. After ten years however, the reservoir had been completely filled with deposits.

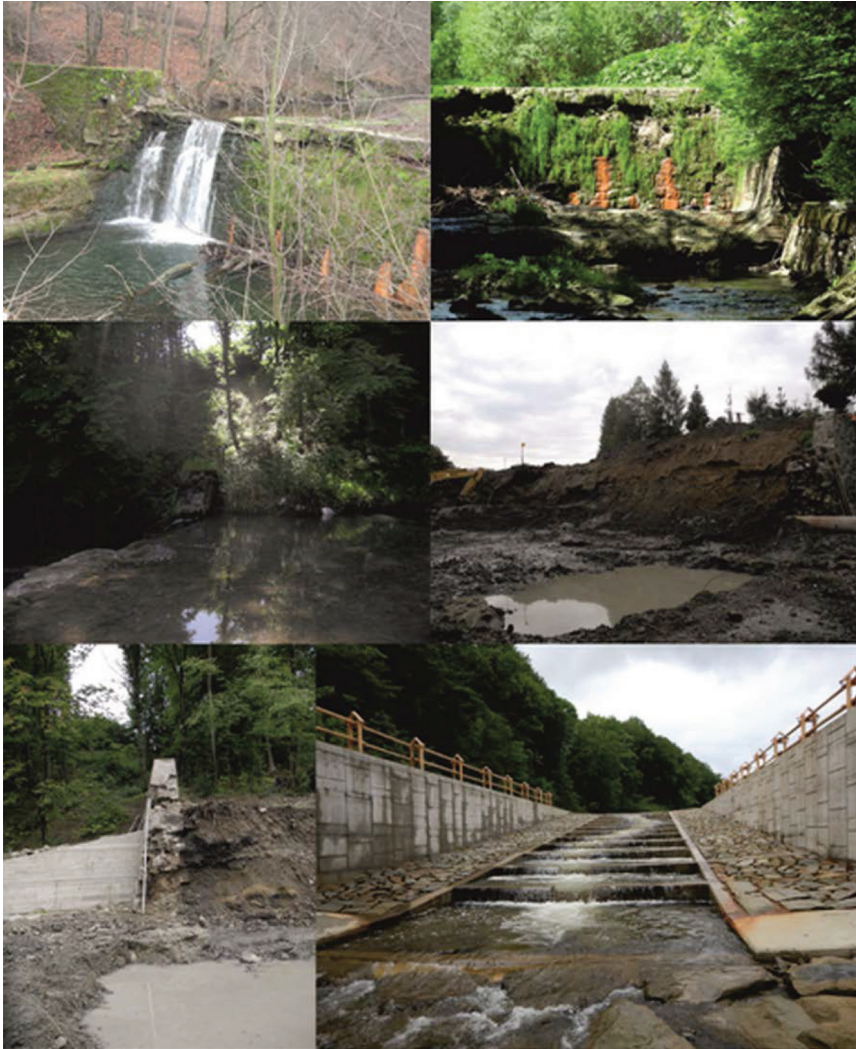
**Figure 3.** From the top clockwise: The dam seen from downstream – year 2012 and 2015; view upstream; reservoir after dam and deposit removal; cascade of basins in place of the main dam body; old dam remains, reservoir before the work commenced

The dam has never been renovated and its state badly deteriorated, downstream river bank erosion started and riverbed rock base appeared as well. Additionally, it was considered to be seriously detrimental for migration of fish. In 2012 the lower part of Trzebuńka river was included in the area of “Tarliska Górnej Raby” Project (Ab Ovo 2011), the dam was proposed to be removed or seriously rebuilt. It was finally decided that a cascade of small basins (twelve of them) would be created in place of the removed main body of the dam (Figure 3). The above mentioned dam re construction/removal is the first such an undertak-

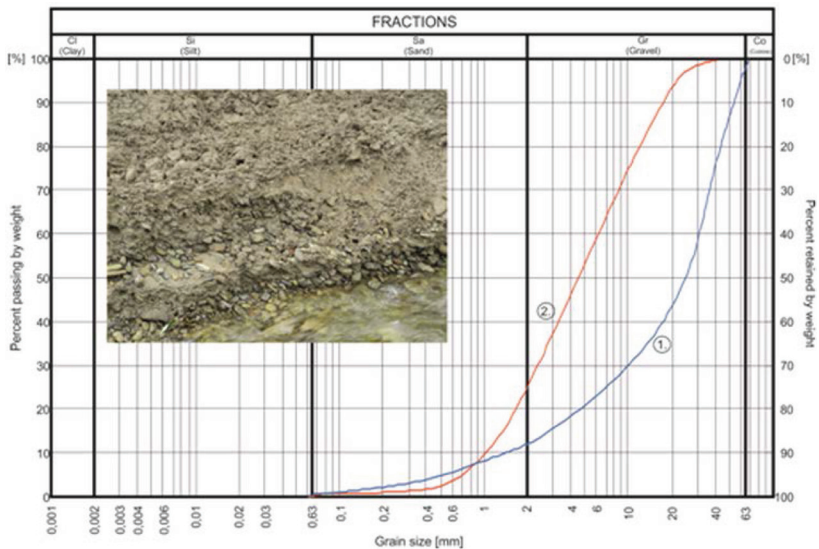
Figure 6. Right bank of the river, partially exposed deposits; grain size distribution curves for the two selected layers

There is a clear division of groups of curves into three parts: coarse, fine and organic sediments. The samples were taken from the both sides of the reservoir. On the right side (looking down the river) mostly the coarse sediment was found (Figure 6). The riverbed layout may indicate that it had been the side of the

former main stream with maximum water velocities, which washed out the fine parts. Probably this is the cause that almost no fine sediments were found there.

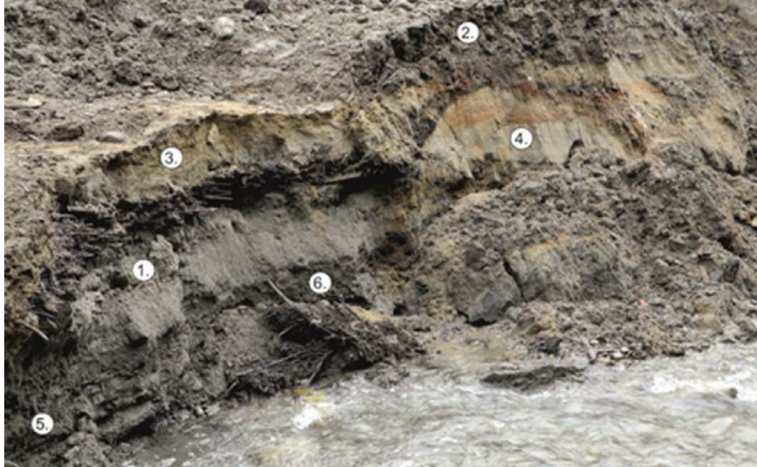
**Figure 7.** Left side of the reservoir, exposed deposited layers

The left side was more diverse, there were six different deposit layers. It is similar to the first sample site (by the dam) as there is a clear distinction into coarse and very fine deposits. Between the two some organic material is clearly visible (see below Figure 7).

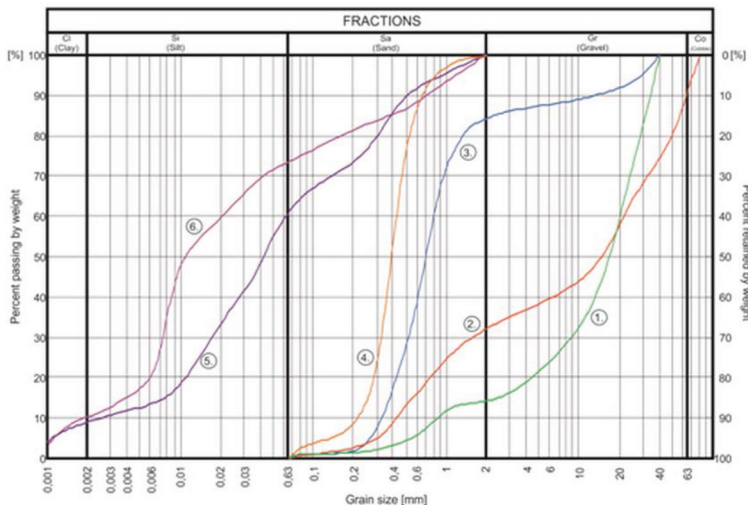
**Figure 8.** Grain distribution curves for deposit samples taken from the left side of the reservoir

Again, the samples were analysed to obtain the grain distribution curves (Figure 8).

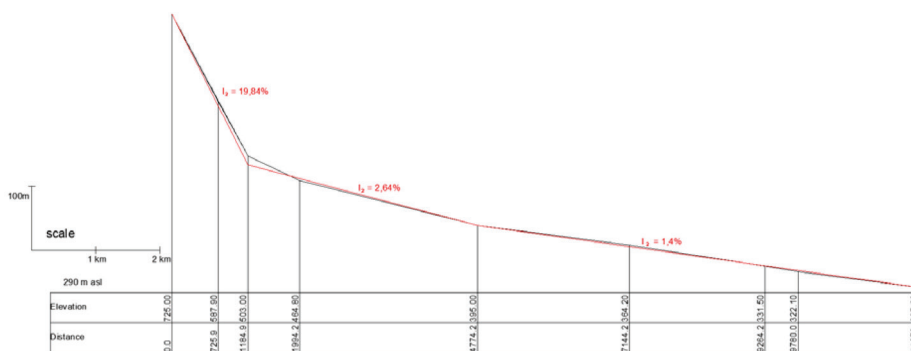
Figure 9. Longitudinal profile of Trzebuńka riverbed, up to its mouth into Raba river (right end)

The mean grain size of deposited material is gradually changing down the river, it is usually sufficient to know the mean value of aggregated slope. For mountain river it is usually enough to use topographic maps with elevation contour lines with map scale of 1:10 000. The longitudinal profile of Trzebuńka river is shown on Figure 9, with three distinct (aggregated) slope values. The averaged slope above the dam is  $i=1.4\%$ . The section length is 6.89 km and according to Osuch it is too long, so additionally the part of the slope inside the reservoir was taken into account. There are, however, two different slope values: first from the map – before the dam was built (empty reservoir) and the second – after long time, with completely filled up reservoir. Therefore, there are two sets of calculations:
